5. To consider reinstating the Patchway Greenway Walk.
6. To consider restoring the Living Landmark trail and signage in Patchway.
7. To elect members to a 'Pollinator Project' working group (3 members of the committee).
8. To note the Annual Play Area inspection report for 2023.

Minutes of the Meeting of the Parks, Open Spaces, Planning and Transport committee held on the Tuesday 3rd October 2023 at 20:00 at Callicroft House, Patchway.

**Gordon Playground
Inspections LTD PSSLive+**

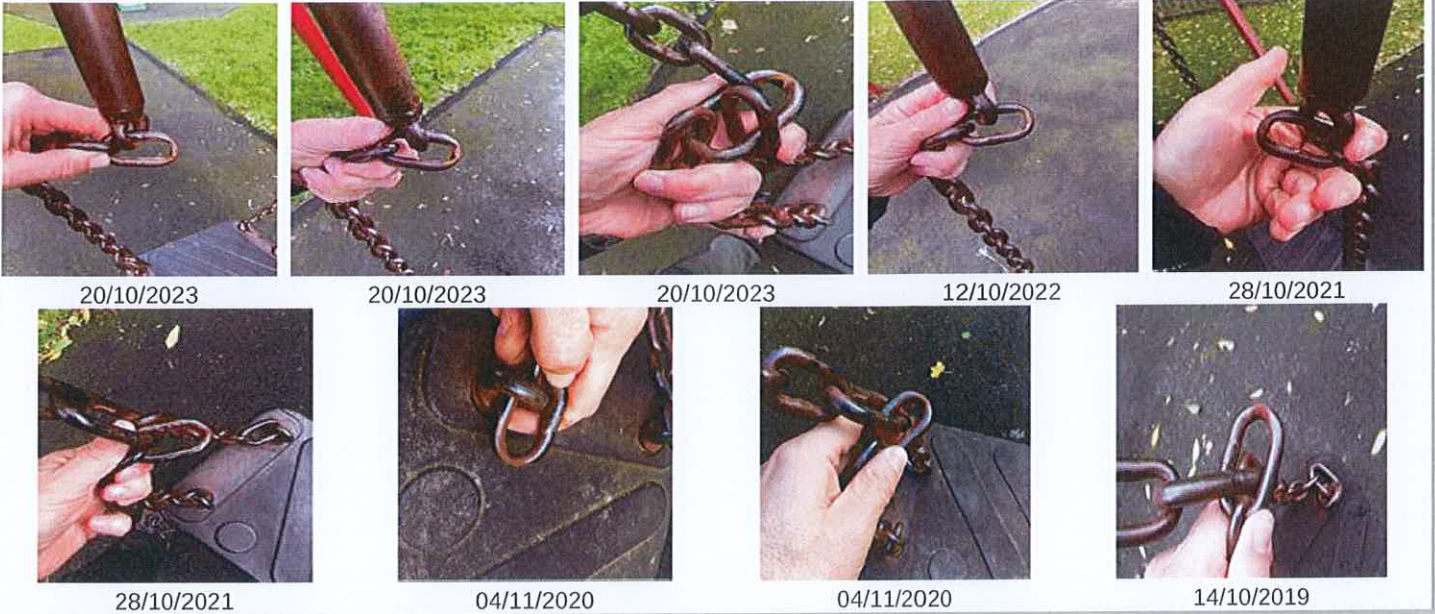
Chain - Links Notched - Task

Task Title	Replace chain links (meeting ISO 1834)
Task Notes	
Task Status	Unapproved

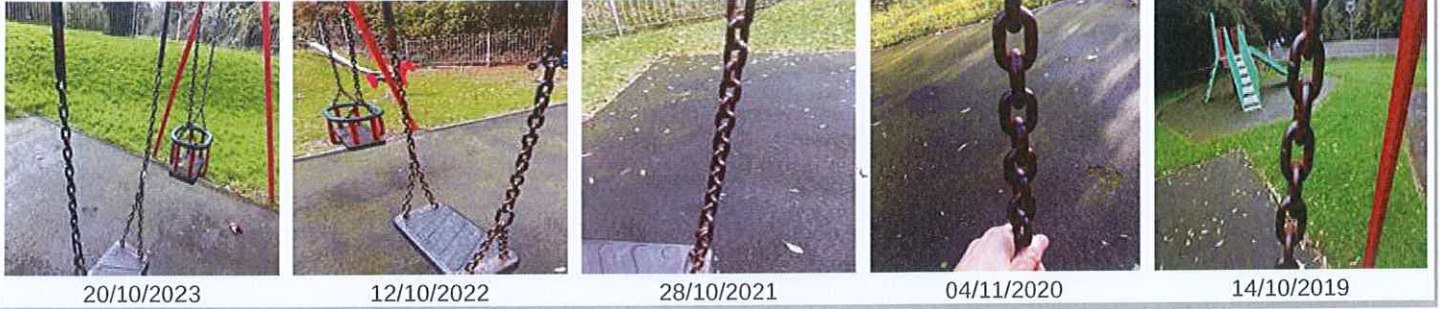
Chains - Compliance - Openings - Links - Task

Task Title	No action given the risk assessment
Task Notes	Replace chains when worn
Task Status	Assigned

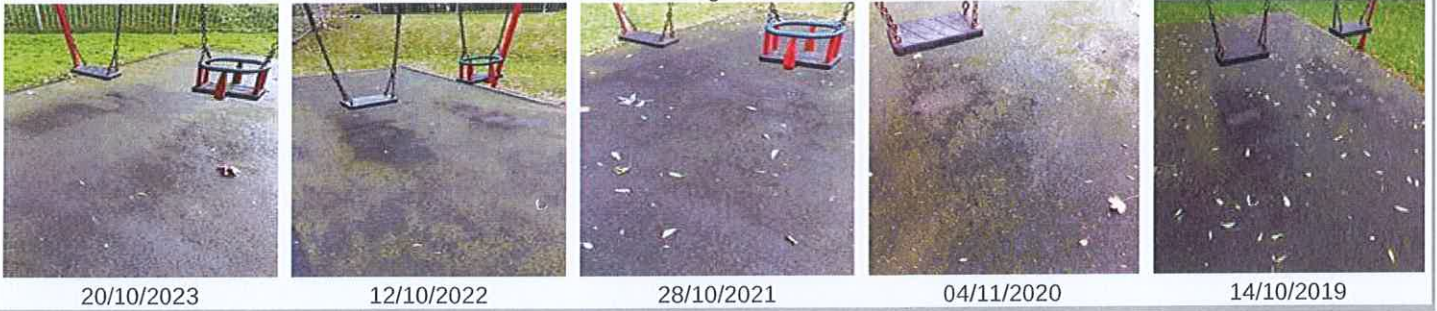
Surface - Wearing - Task

Task Title	Monitor
Task Notes	
Task Status	Unapproved

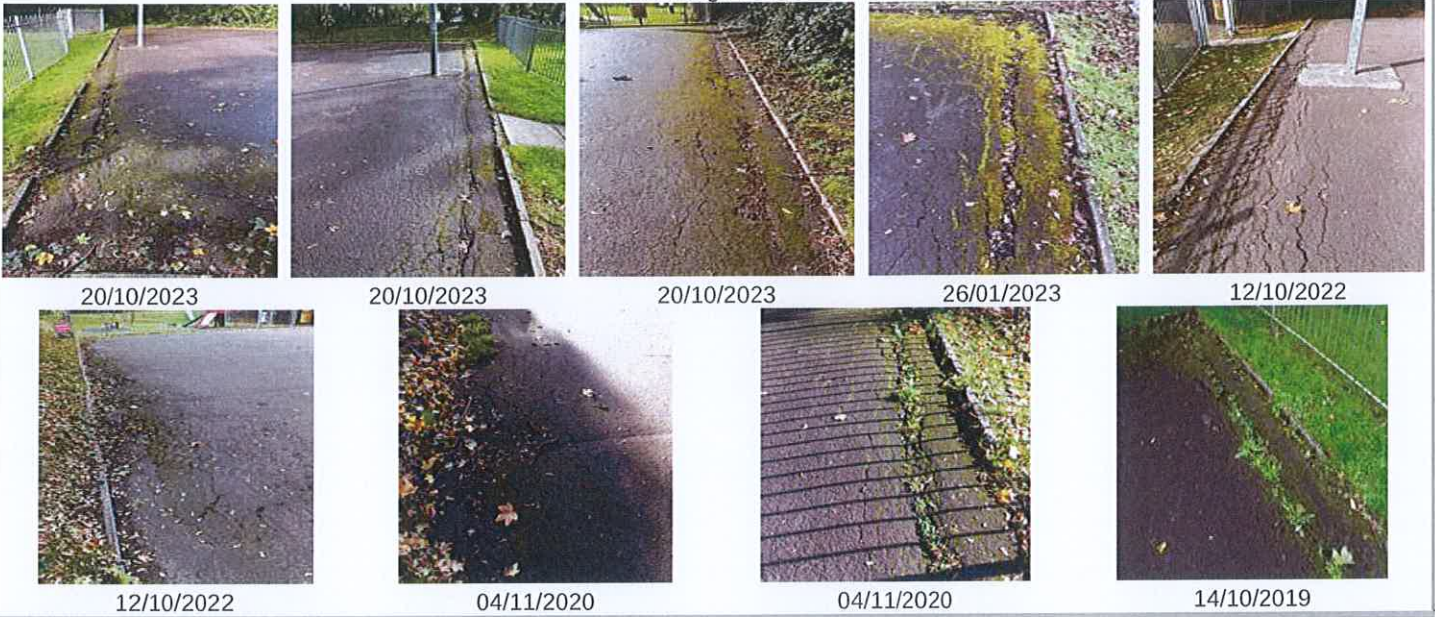
Surface - Trip points - Task

Task Title	Repair surface
Task Notes	
Task Status	Unapproved

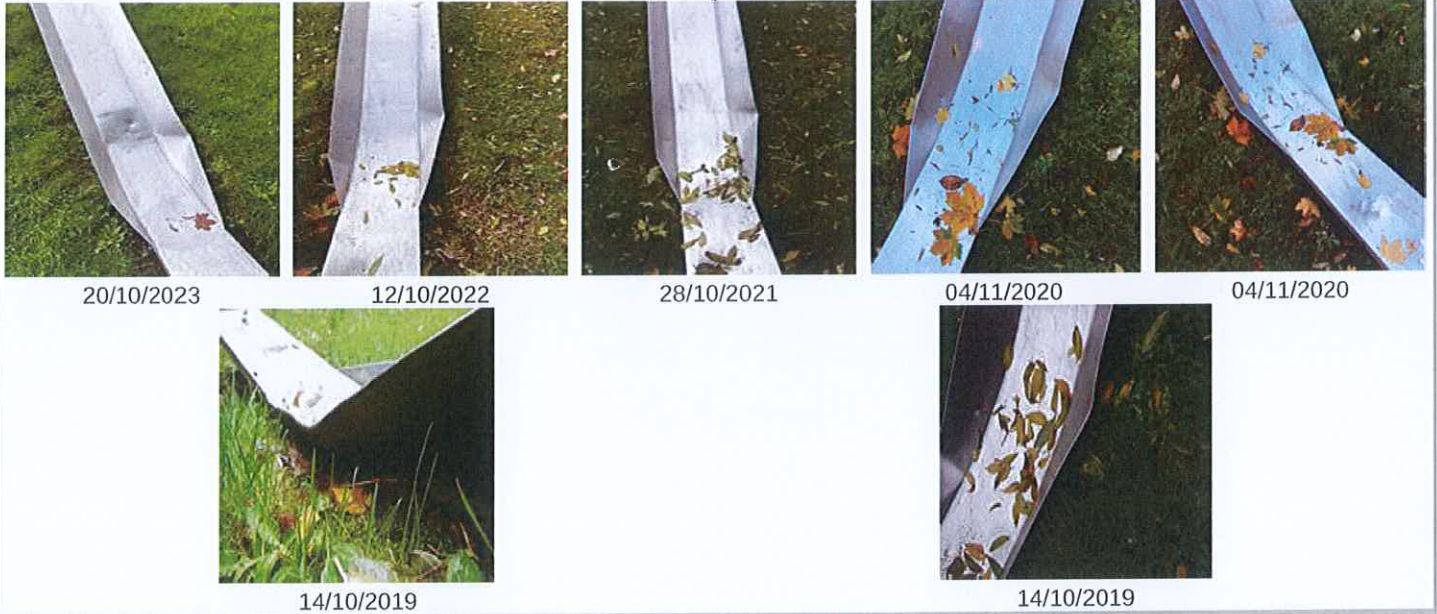
Item - Bent - Task

Task Title	Monitor
Task Notes	
Task Status	Unapproved

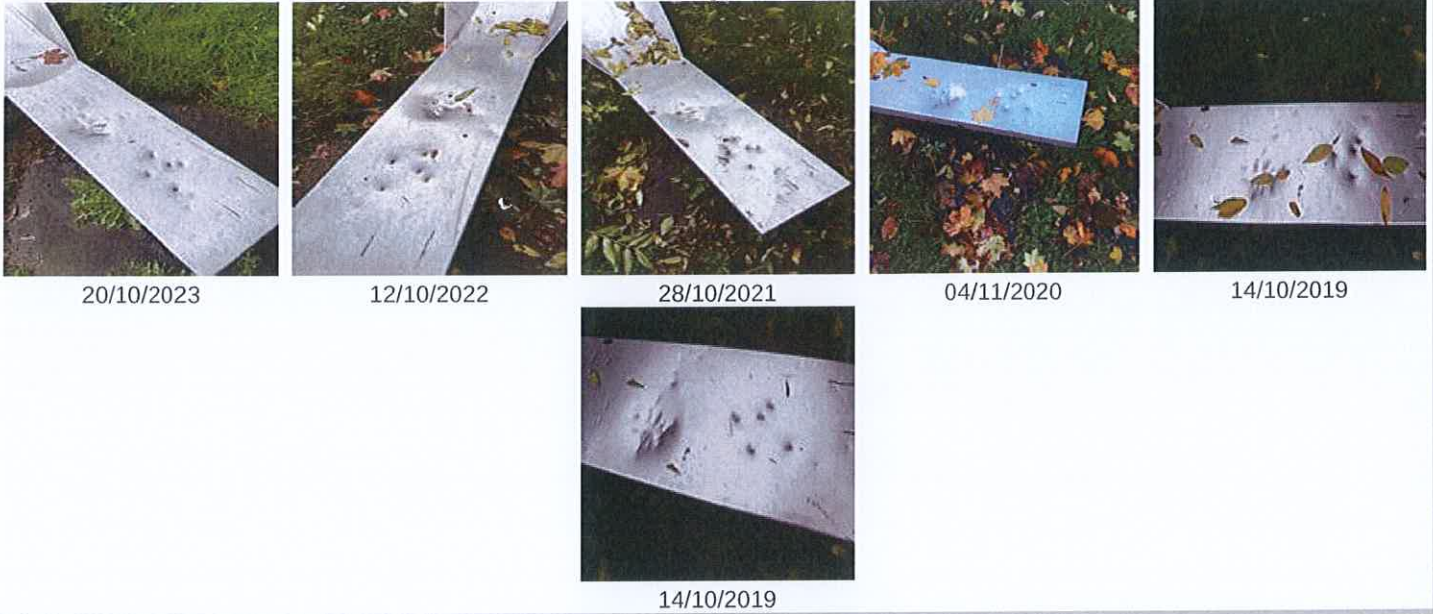
Item - Damaged - Task

Task Title	Monitor
Task Notes	
Task Status	Unapproved

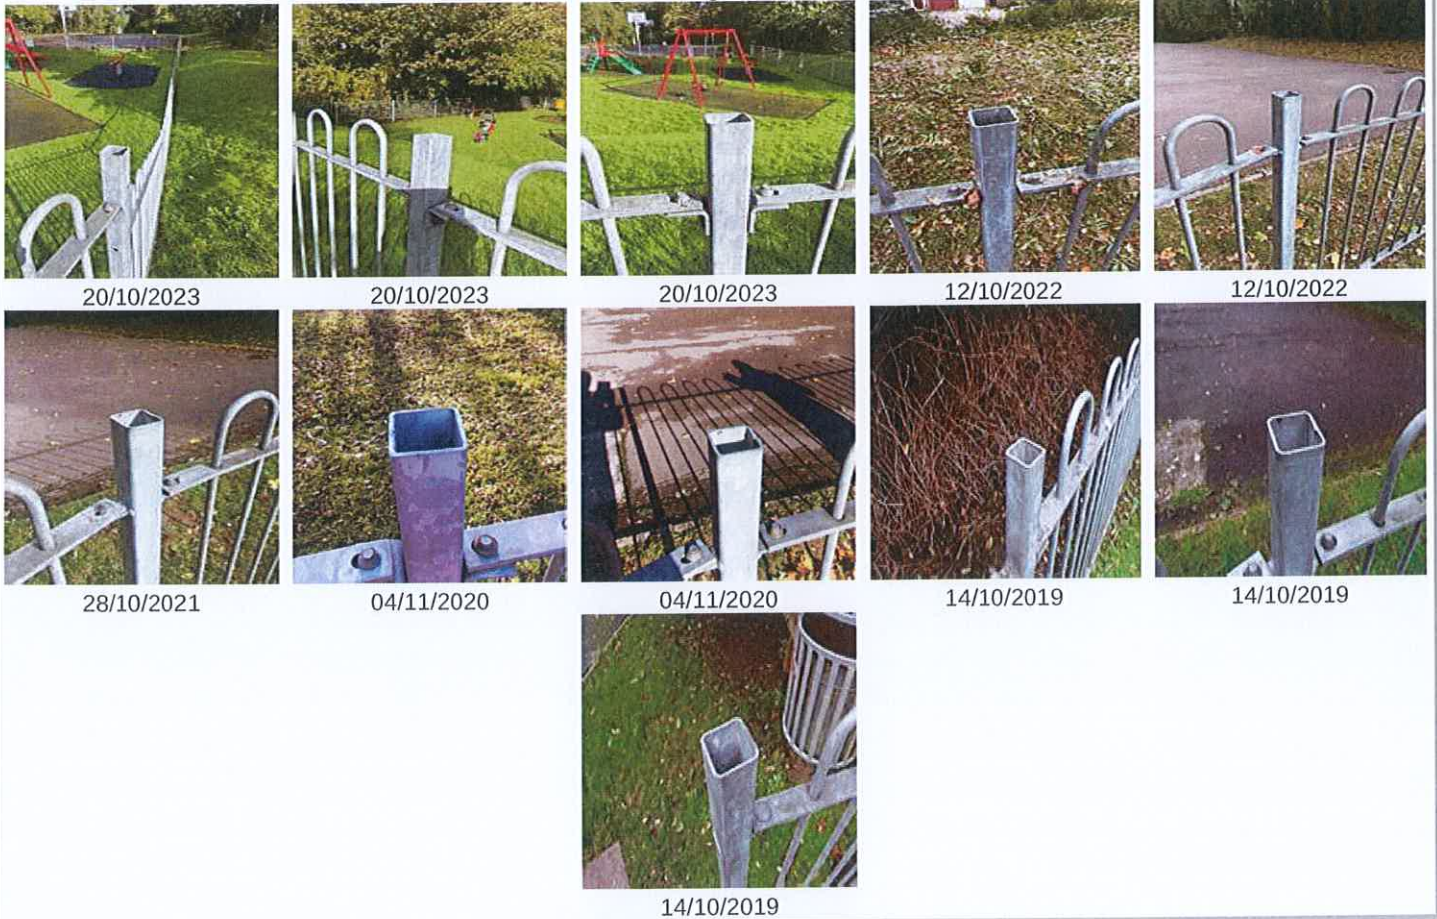
Item - Cap(s) missing - Task

Task Title	Replace
Task Notes	
Task Status	Unapproved

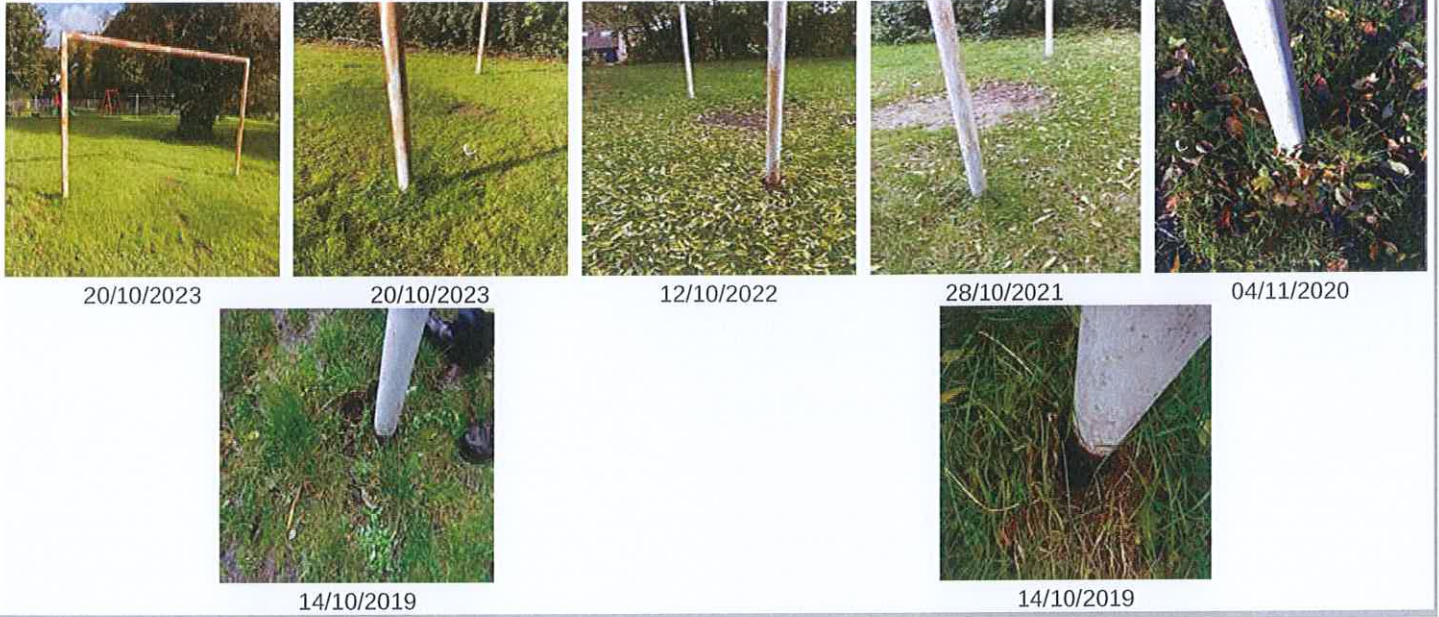
Item - Loose in Ground - Task

Task Title	Repair item
Task Notes	
Task Status	Unapproved

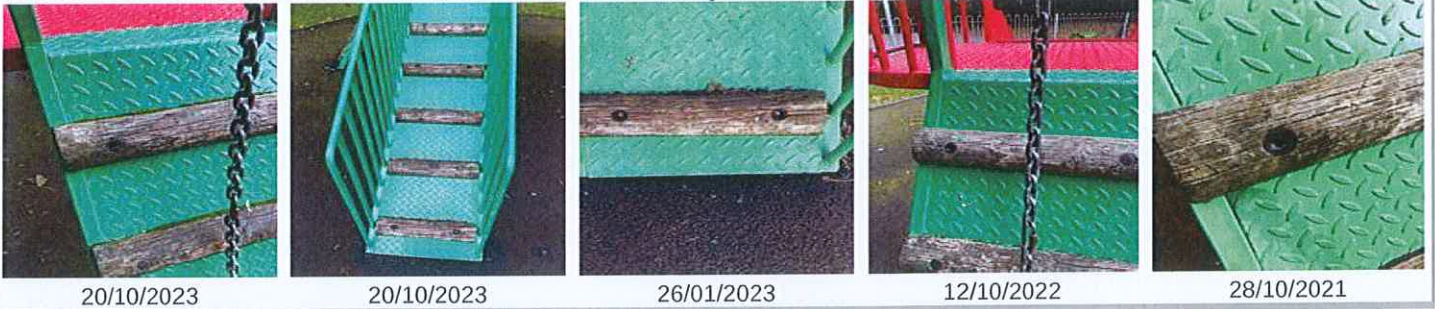
Item - Cap(s) damaged - Task

Task Title	Replace item
Task Notes	
Task Status	Unapproved

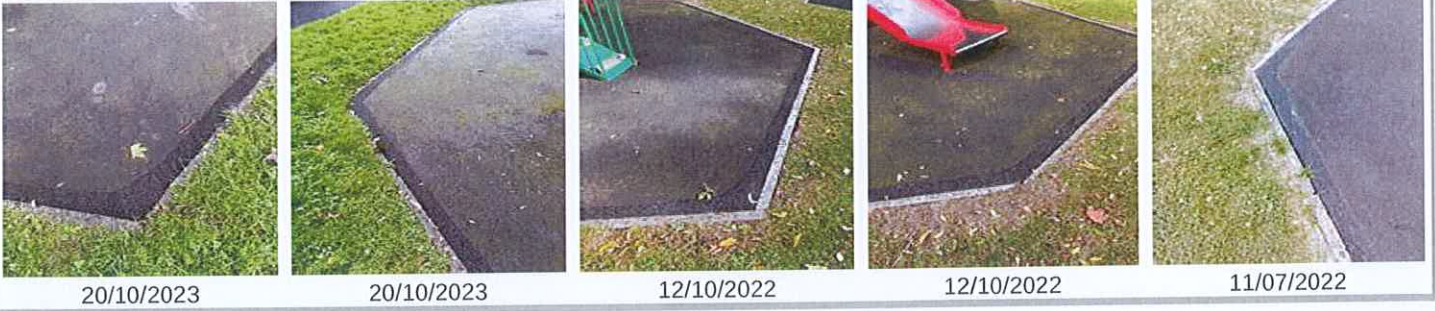
Surface - Edges Curling - Tasks

Task Title	Monitor
Task Notes	
Task Status	Unapproved

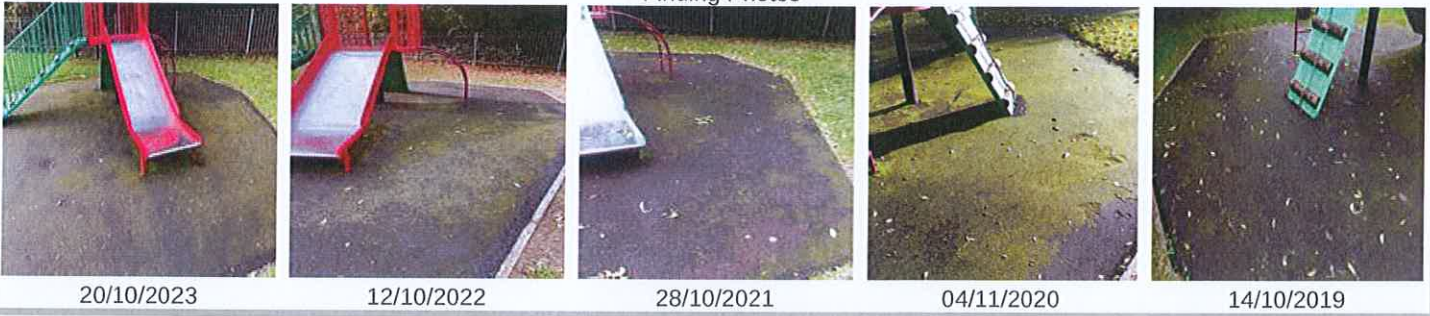
Surface - Moss - Task

Task Title	Power Wash
Task Notes	
Task Status	Unapproved

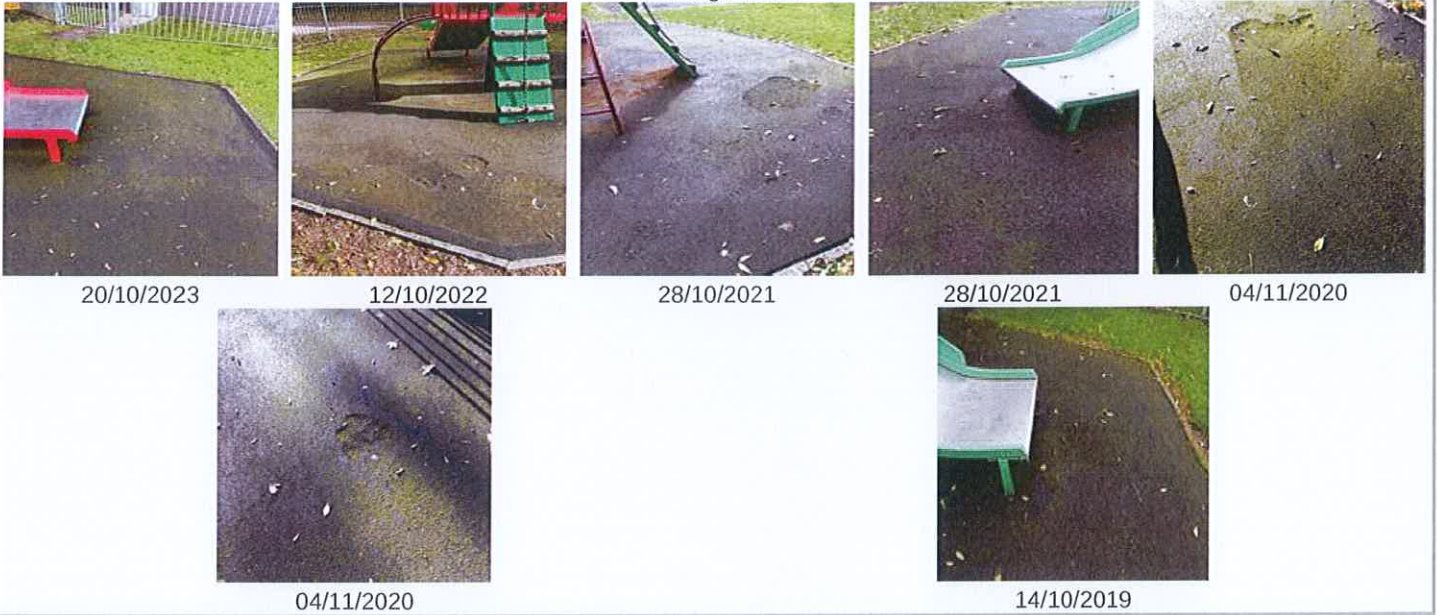
Surface - Wearing - Task

Task Title	Monitor
Task Notes	
Task Status	Unapproved

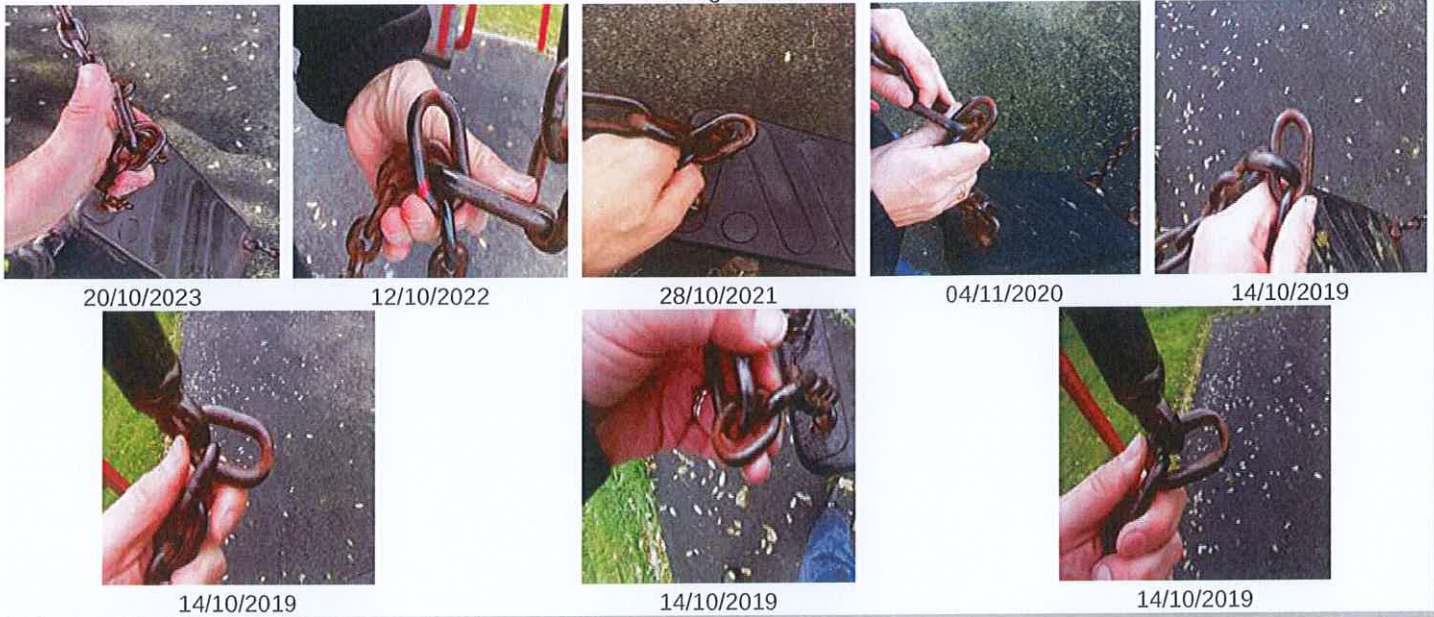
Chain - Links Notched - Task

Task Title	Monitor
Task Notes	
Task Status	Unapproved

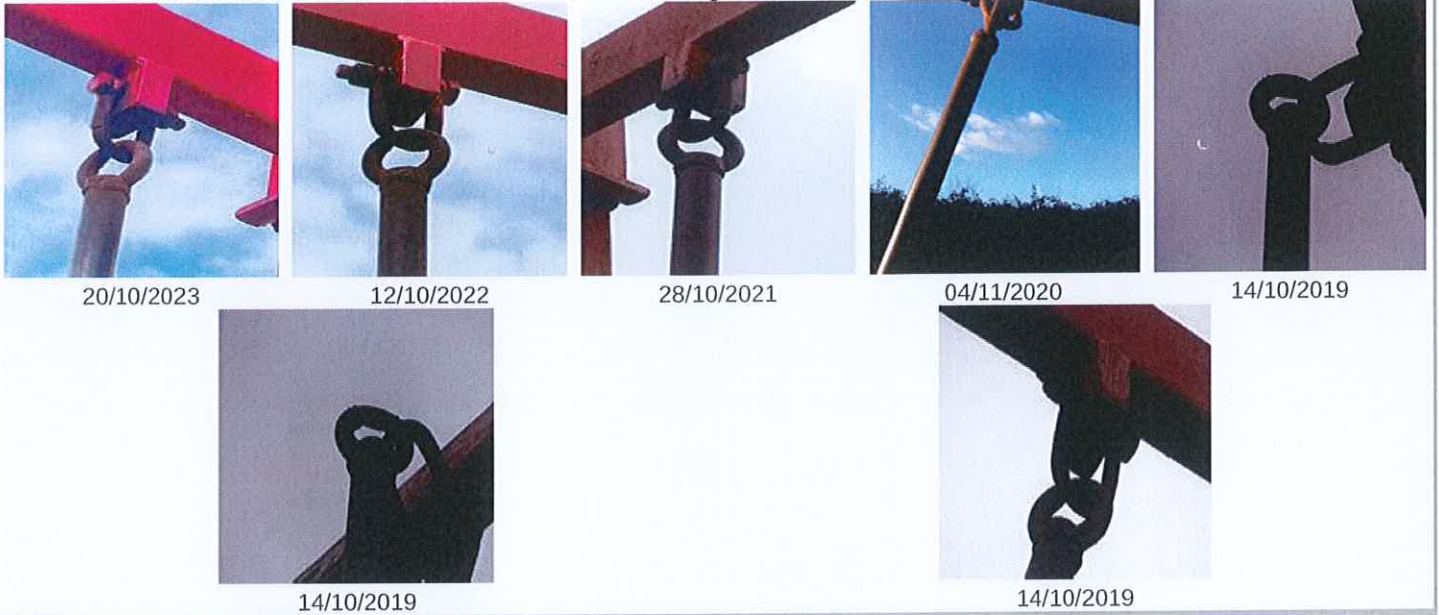
Chain - Connectors Notched - Task

Task Title	Monitor
Task Notes	
Task Status	Unapproved

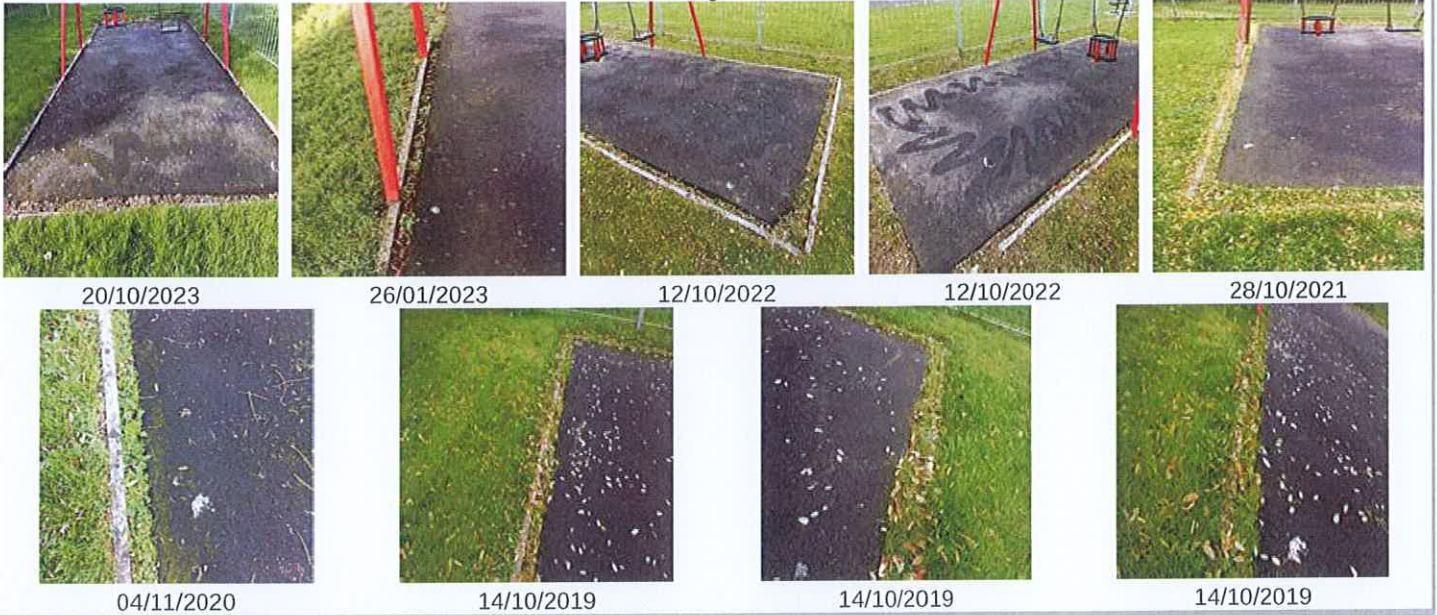
Surface - Edges Shrunk - Task

Task Title	Repair edges
Task Notes	
Task Status	Unapproved

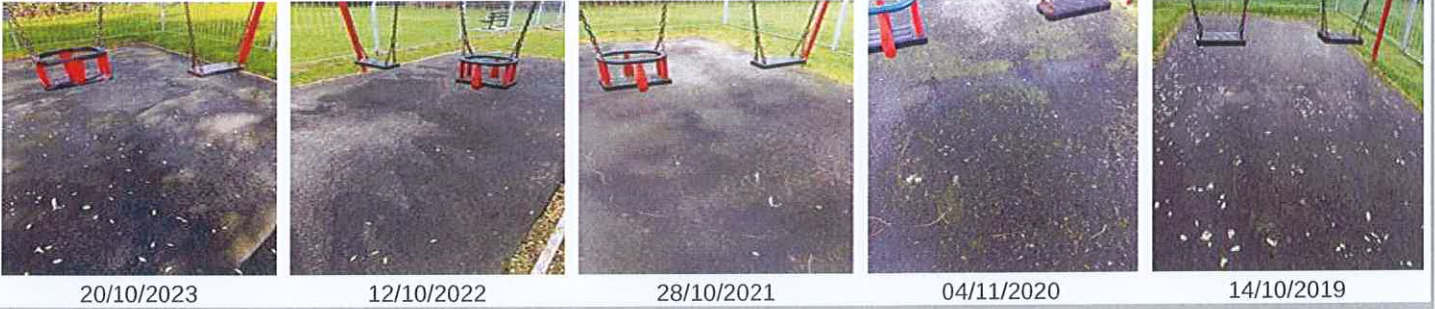
Surface - Worn - Task

Task Title	Monitor
Task Notes	
Task Status	Unapproved

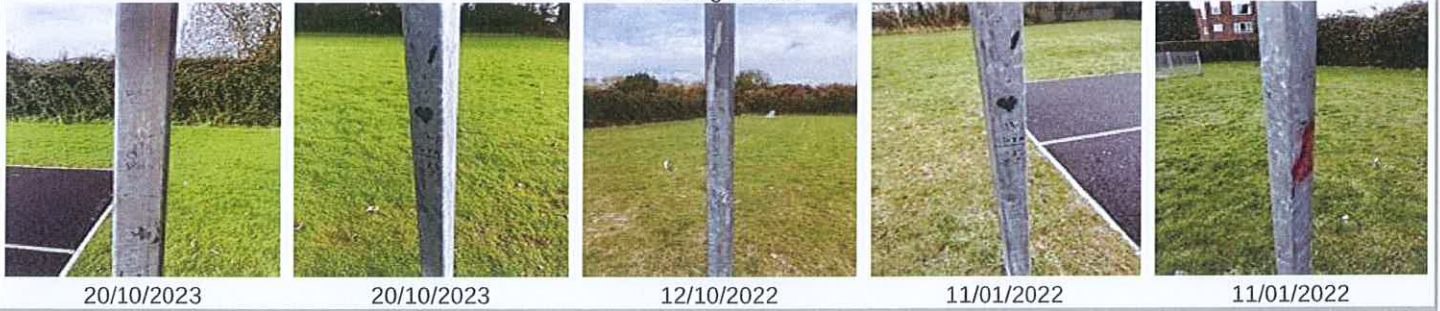
Item - Graffiti - Present - Tasks

Task Title	Remove graffiti
Task Notes	
Task Status	Unapproved

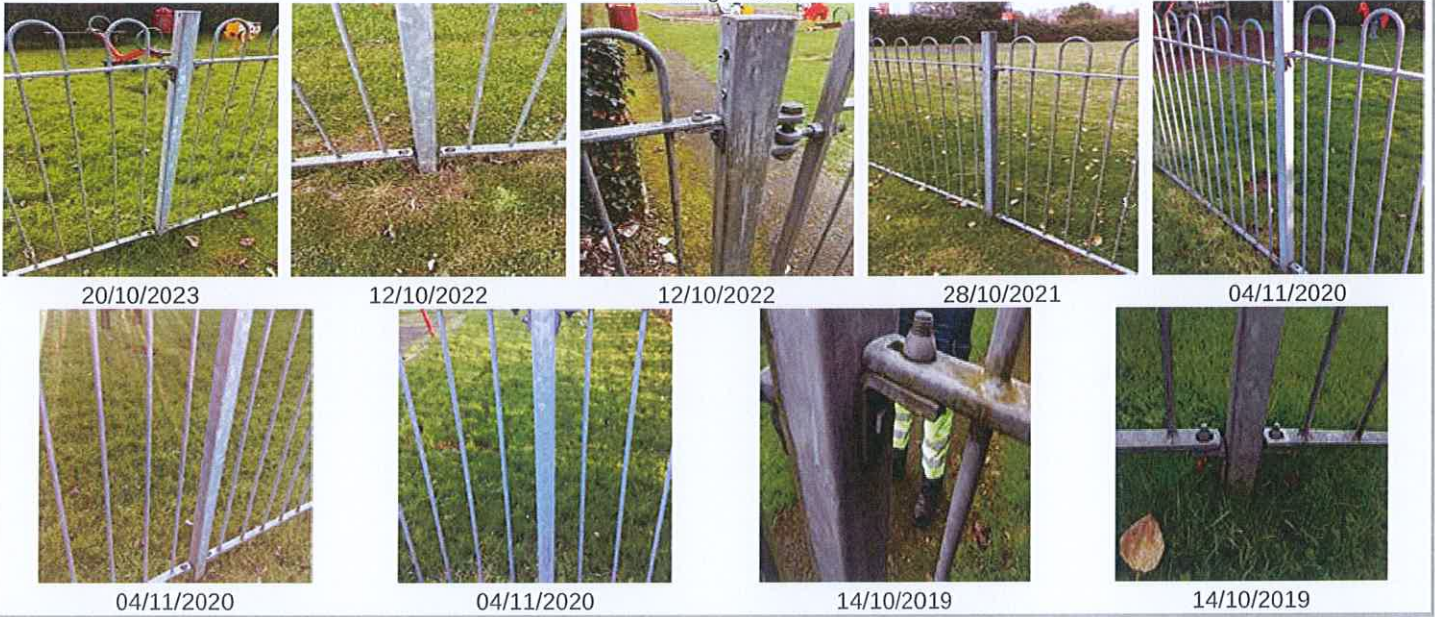
Fixtures - Loose or Missing - Task

Task Title	Tighten loose fixtures & fittings
Task Notes	
Task Status	Unapproved

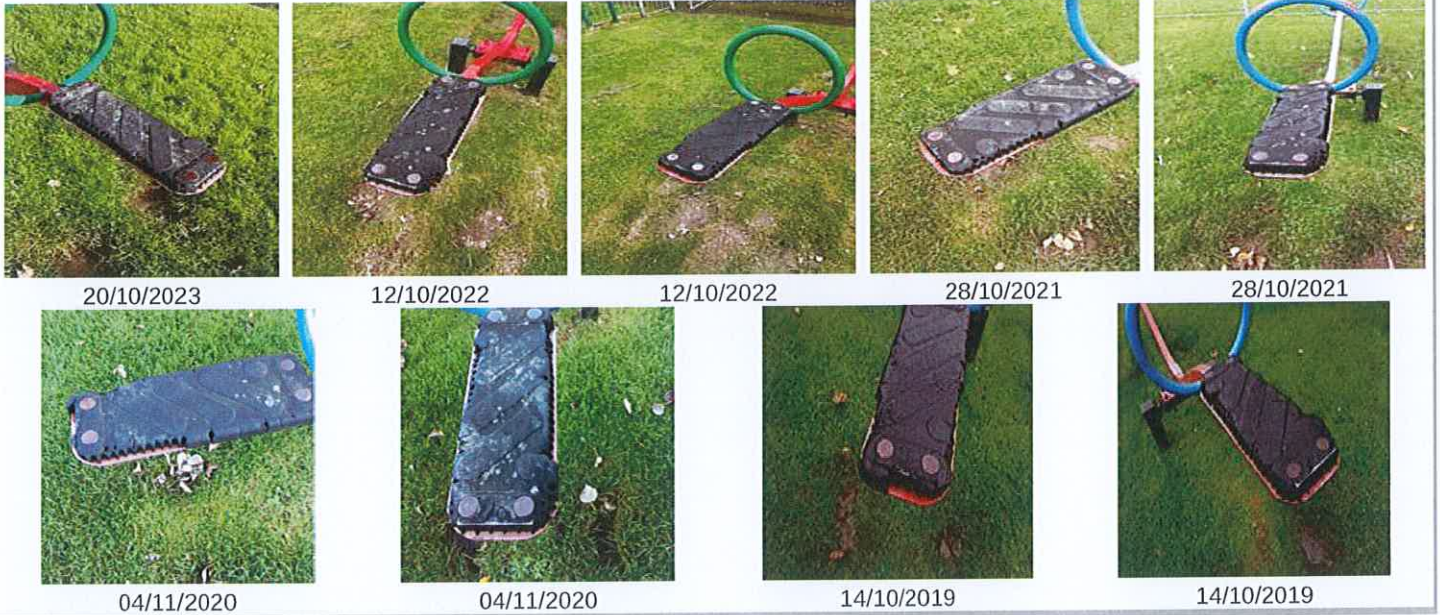
Item - Damaged - Task

Task Title	Replace item
Task Notes	
Task Status	Unapproved

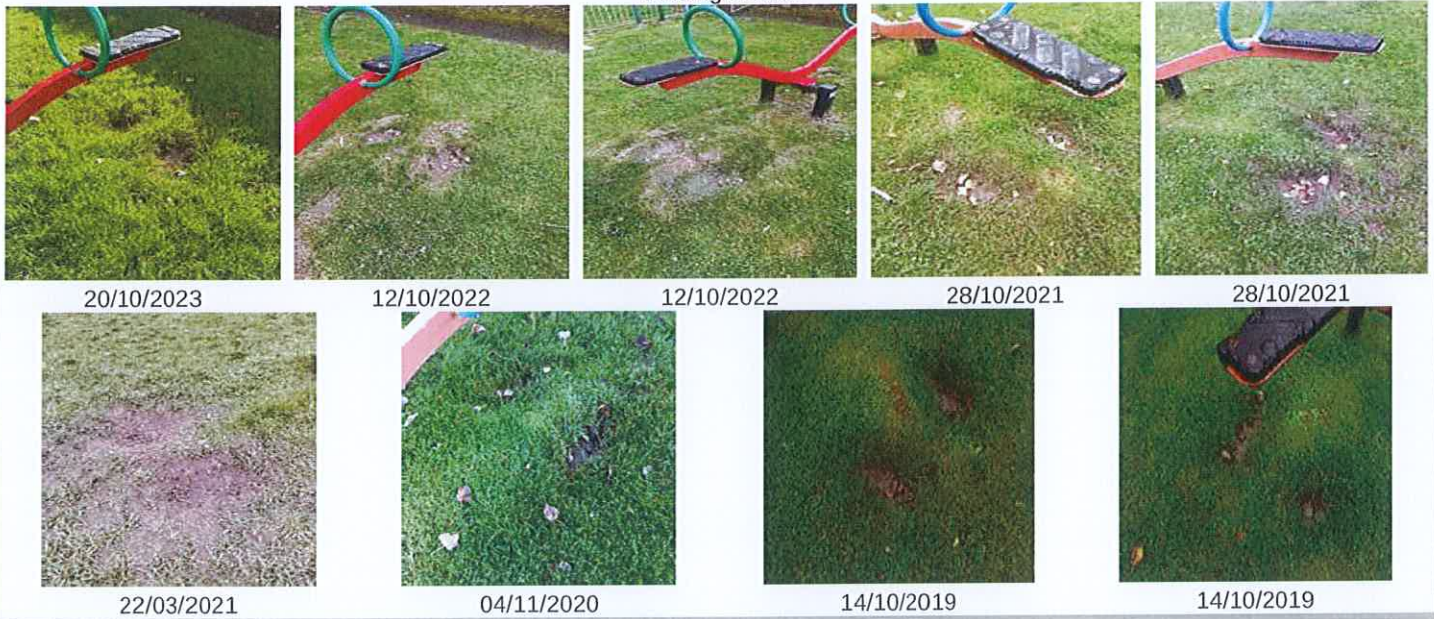
Ground Eroded - Task

Task Title	Make good surface
Task Notes	Needs soil and seed
Task Status	Assigned
Task Photos	
  <p>17/05/2023</p>	  <p>17/05/2023</p>

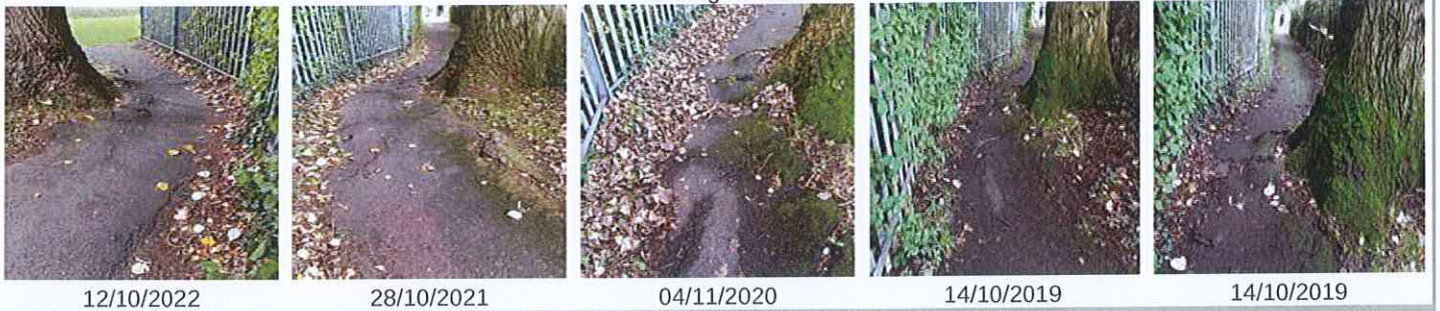
Surface - Trip points - Task

Task Title	Repair surface
Task Notes	
Task Status	Unapproved

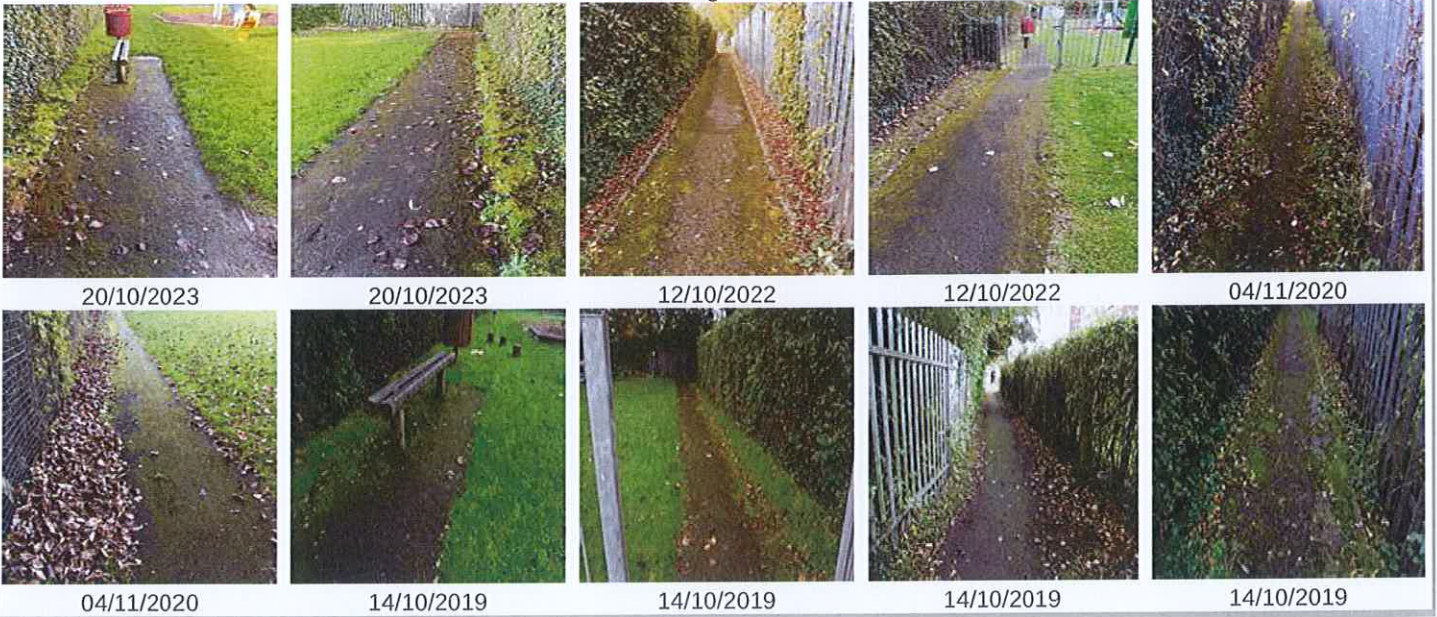
Surface - Moss - Task

Task Title	Power Wash
Task Notes	Needs treatment
Task Status	Assigned

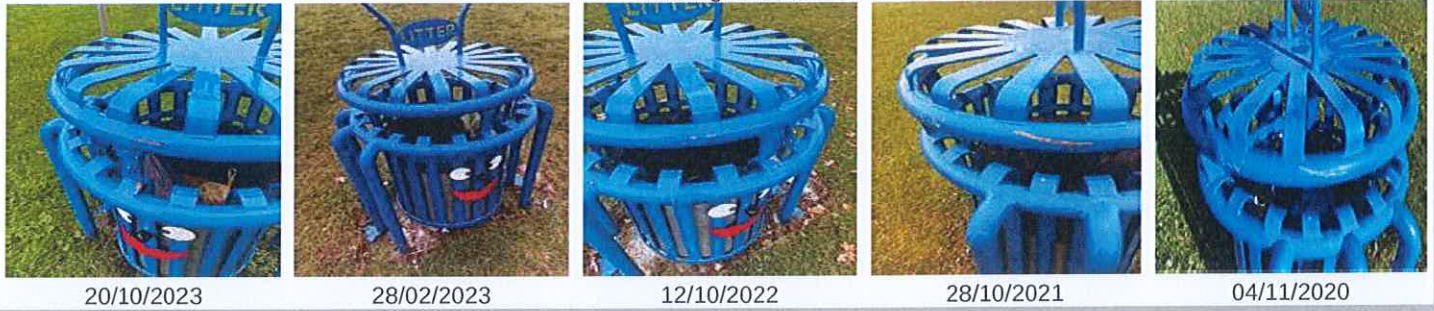
Metal - Paint-work - Not in Good Condition - Tasks

Task Title	Repair damaged area(s)
Task Notes	
Task Status	Unapproved

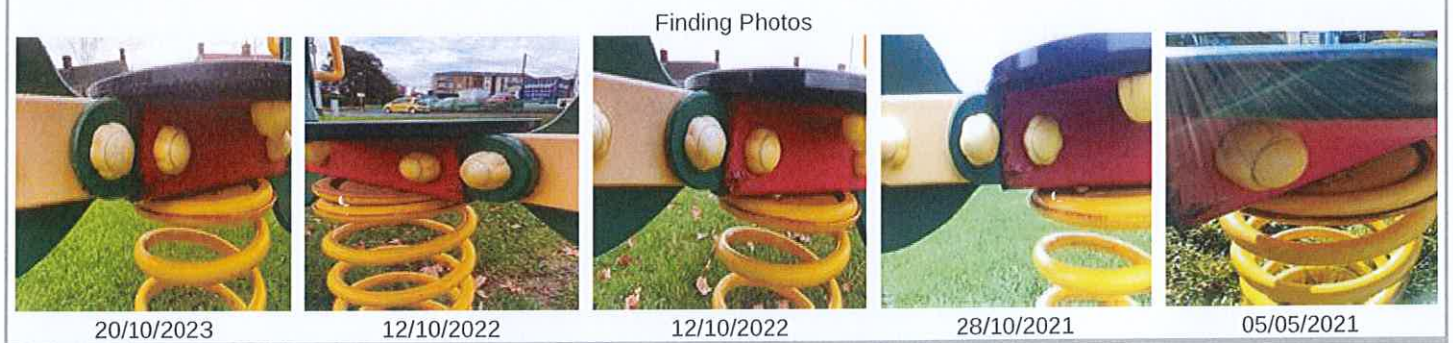
<p>Asset Photo</p>
Finding Group	Maintenance	
Finding Title	Item - Rusting in places	
Standard Reference		
Standard Description	Item is rusting in places	
Finding Notes	Metal work under seat starting to rust and blow paintwork	
Cause	Wear and Tear	
Finding Creation Date	05/05/2021 07:42:44	
Risk Value Text	1 x 2 = 2	
Risk Level	Very Low	
Resolve By Date	05/07/2023 10:34:50	
Finding Status	Open

Item - Rusting in places - Task

Task Title	De-rust and coat with paint meeting EN 1176 - 4.1.1 [1998]
Task Notes	Needs de rusting and painting
Task Status	Assigned

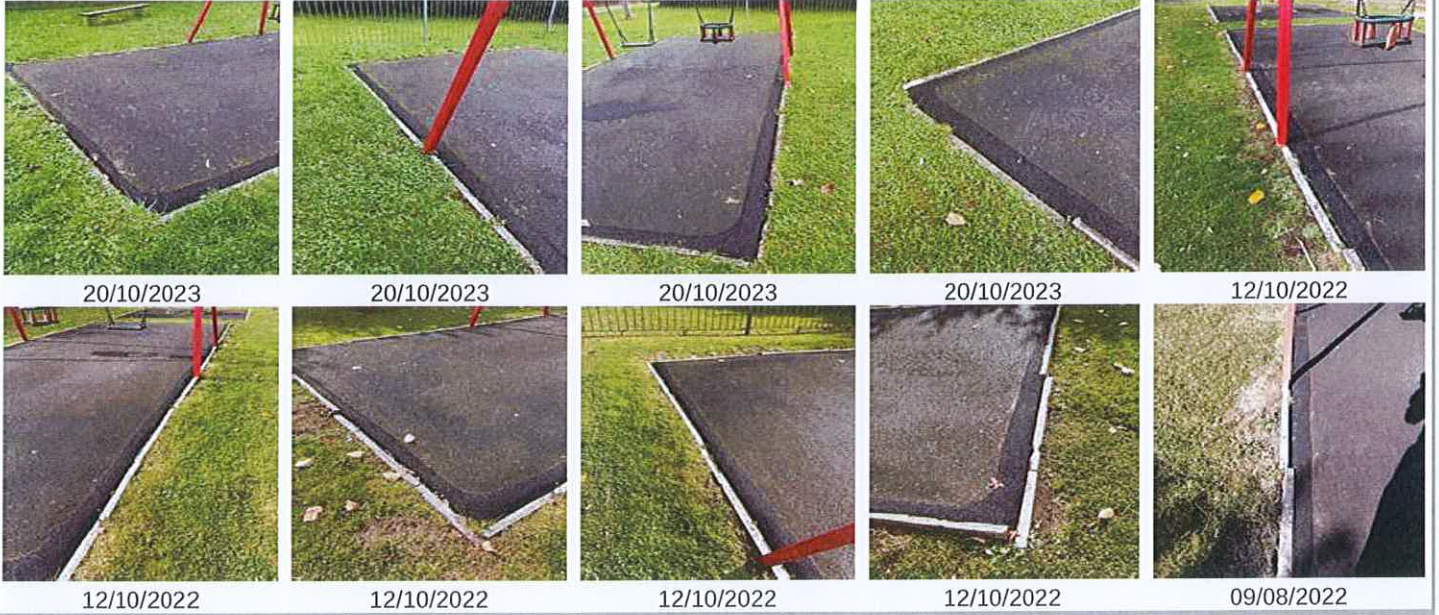
Surface - Edges Shrunk - Task

Task Title	Repair edges
Task Notes	
Task Status	Unapproved

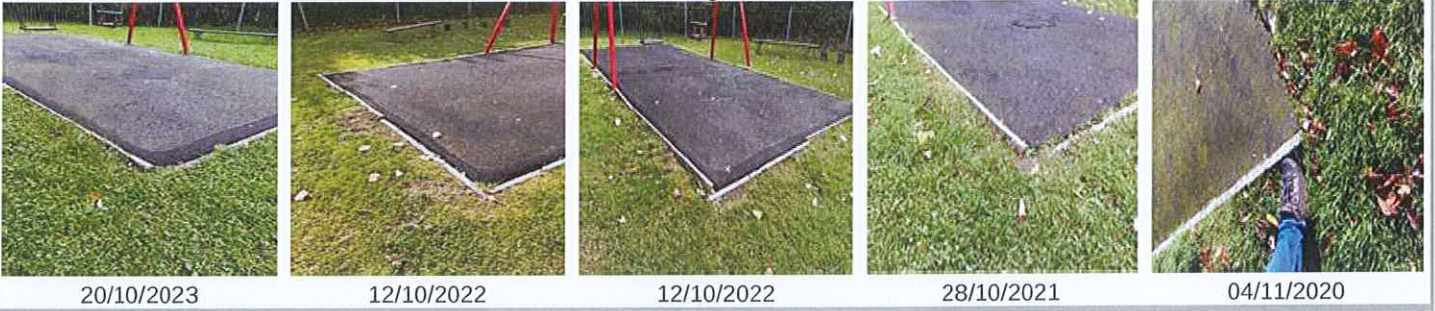
Surface - Trip points - Task

Task Title	Repair surface
Task Notes	
Task Status	Unapproved

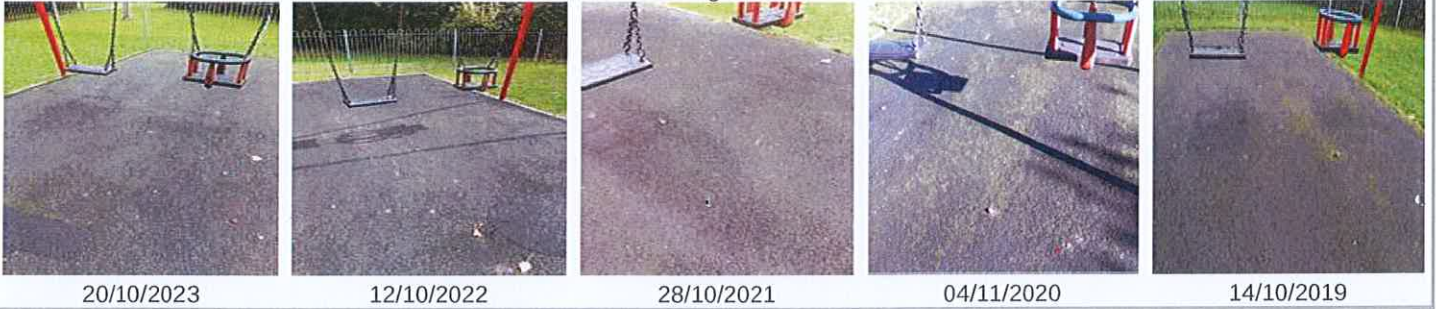
Surface - Wearing - Task

Task Title	Monitor
Task Notes	
Task Status	Unapproved

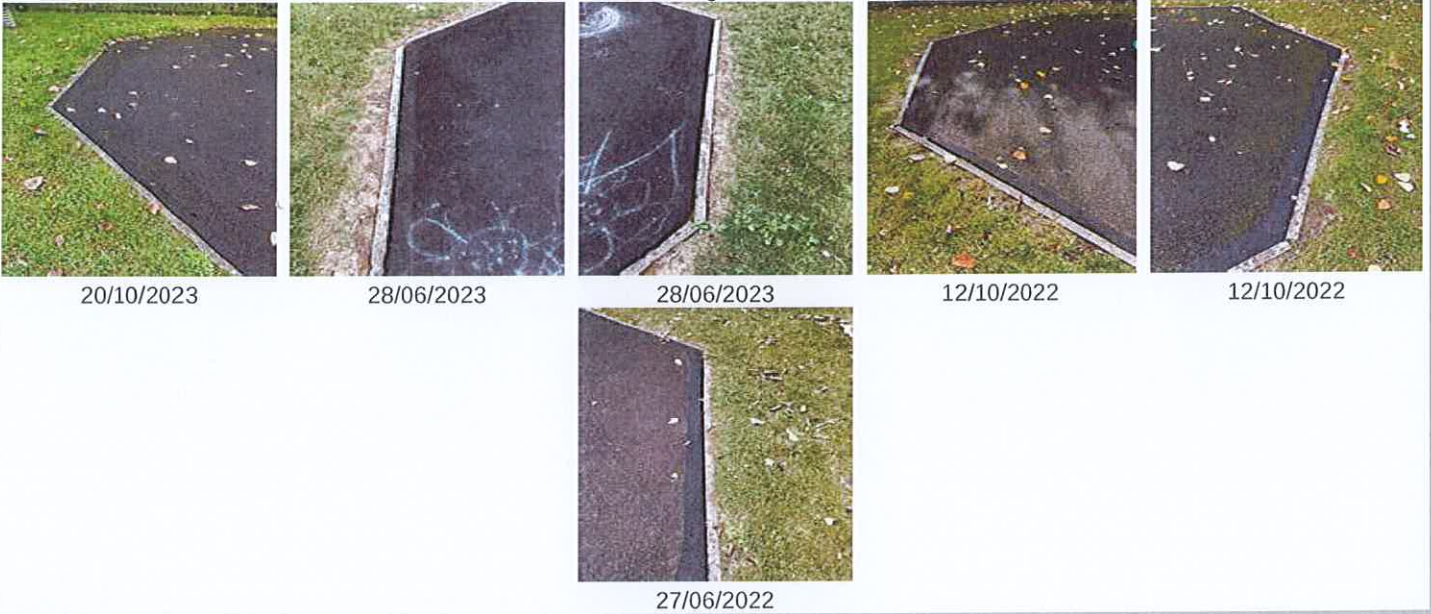
Surface - Edges Shrunk - Tasks

Task Title	Repair edges
Task Notes	
Task Status	Unapproved

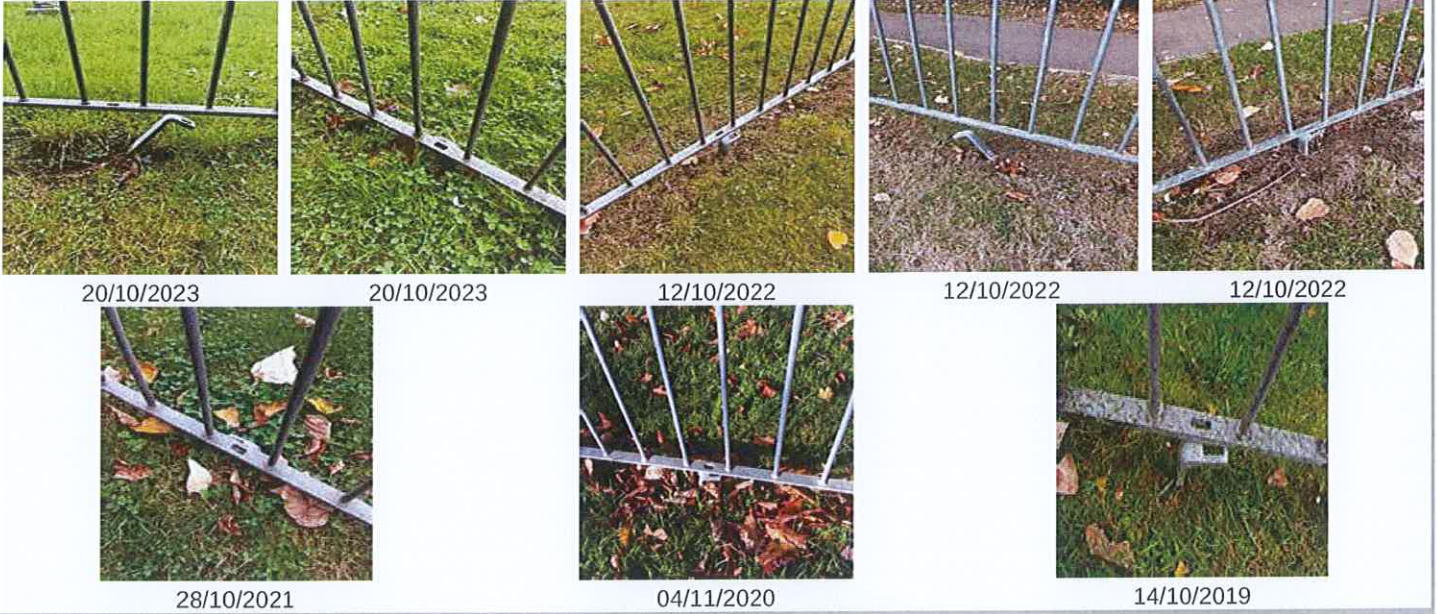
Fixtures - Loose or Missing - Task

Task Title	Replace missing fasteners, fixtures and fitting
Task Notes	
Task Status	Unapproved

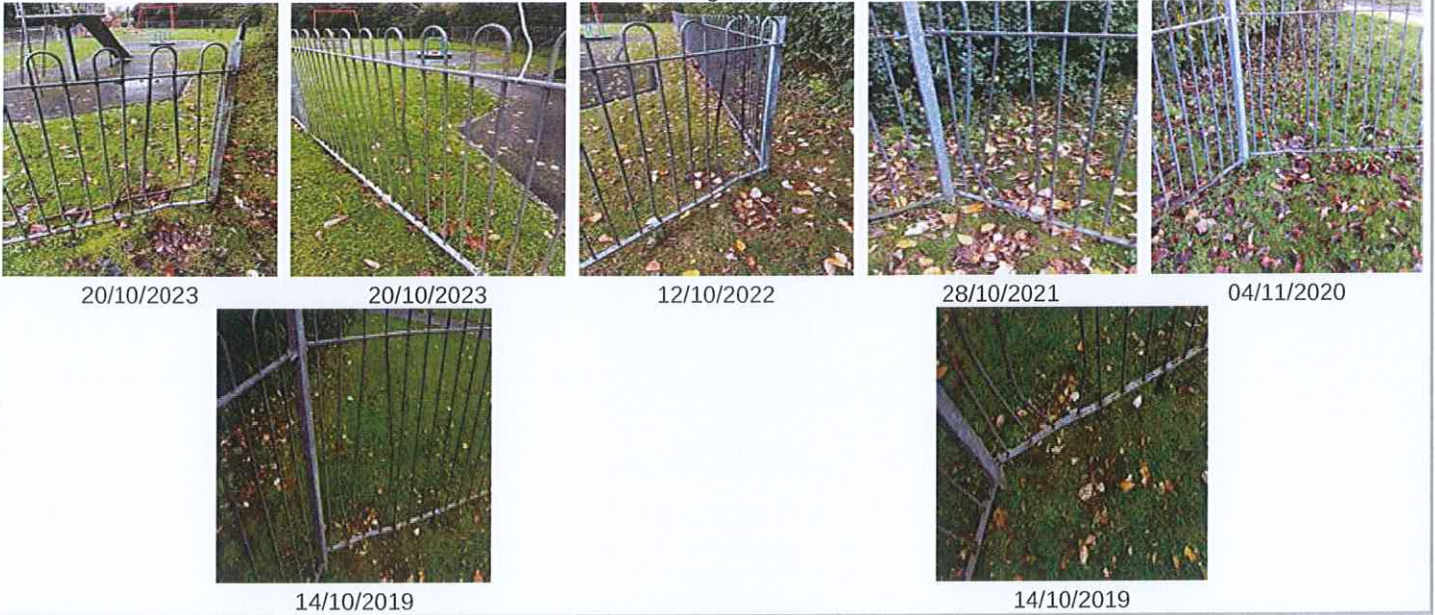
Item - Bent - Task

Task Title	Repair item
Task Notes	
Task Status	Assigned
