5. To consider reinstating the Patchway Greenway Walk.
6. To consider restoring the Living Landmark trail and signage in Patchway.
7. To elect members to a 'Pollinator Project' working group (3 members of the committee).
8. To note the Annual Play Area inspection report for 2023.

Minutes of the Meeting of the Parks, Open Spaces, Planning and Transport committee held on the Tuesday 3rd October 2023 at 20:00 at Callicroft House, Patchway.

**Gordon Playground
Inspections LTD PSSLive+**

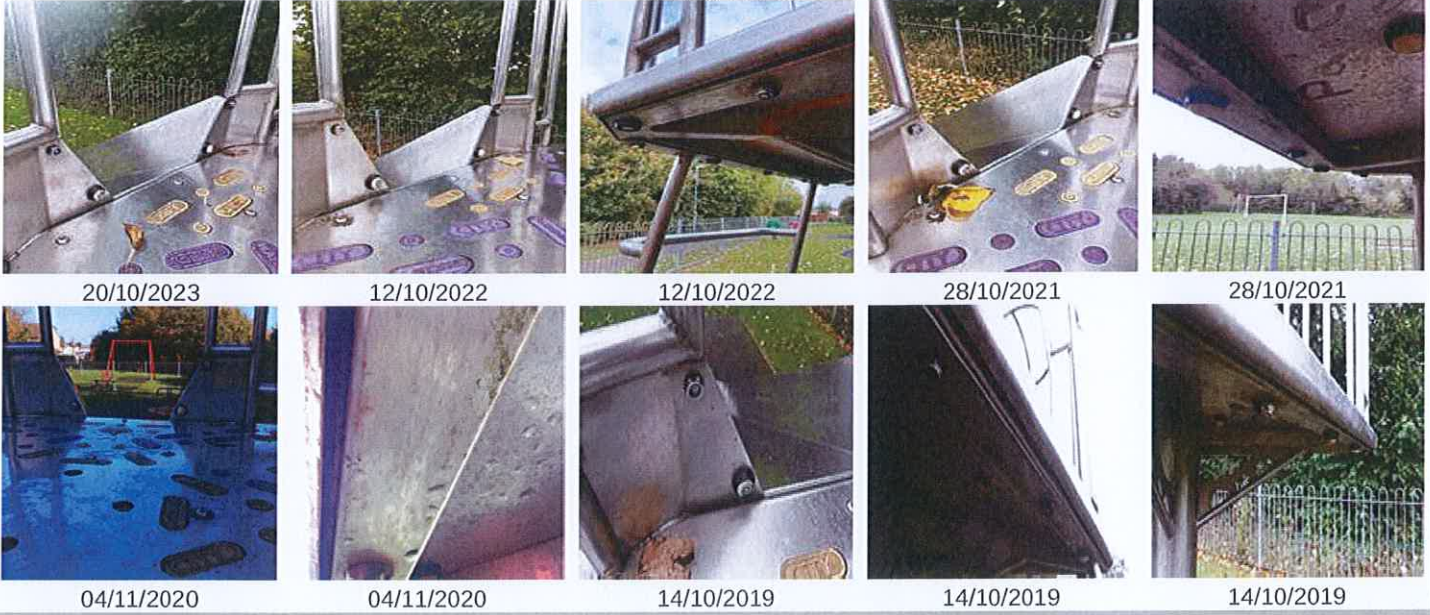
Item - Cap(s) missing - Task

Task Title	Replace
Task Notes	
Task Status	Unapproved

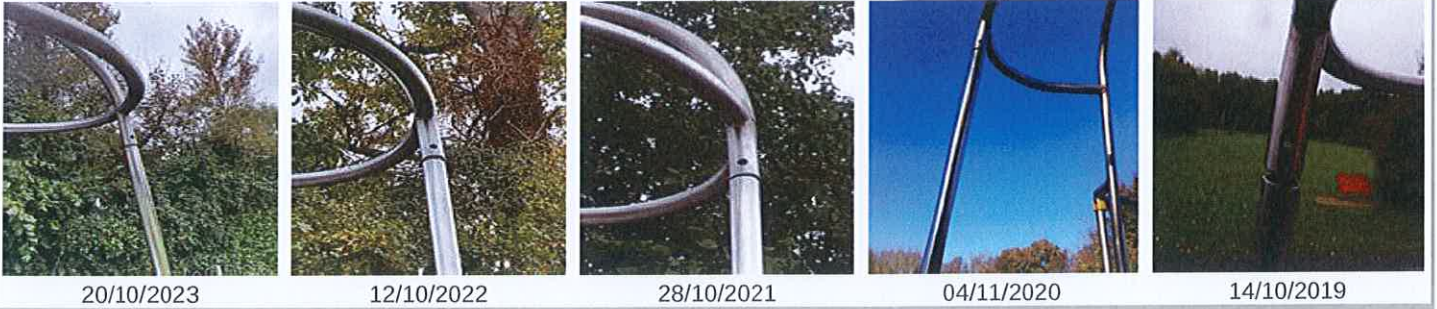
Fixtures - Loose or Missing - Task

Task Title	Replace missing fasteners, fixtures and fitting
Task Notes	
Task Status	Unapproved

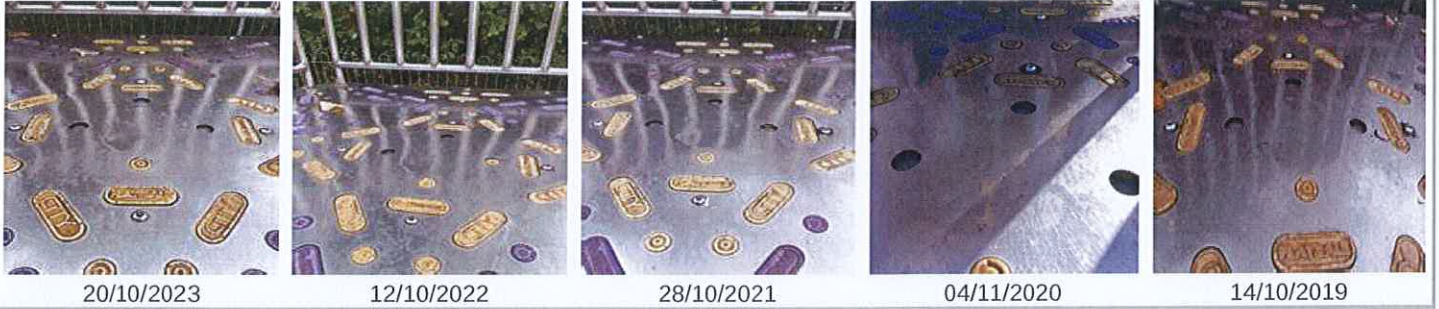
Item - Parts Missing - Task

Task Title	Replace missing parts
Task Notes	
Task Status	Unapproved

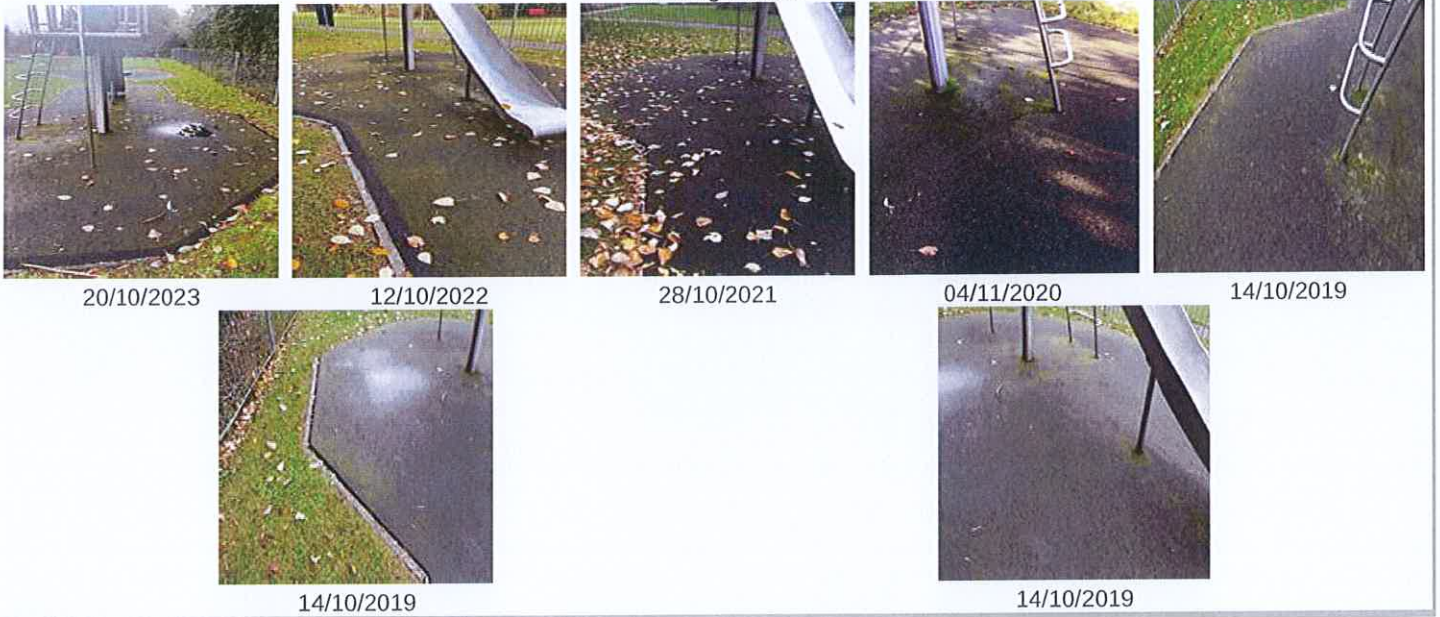
Surface - Moss - Task

Task Title	Power Wash
Task Notes	
Task Status	Unapproved

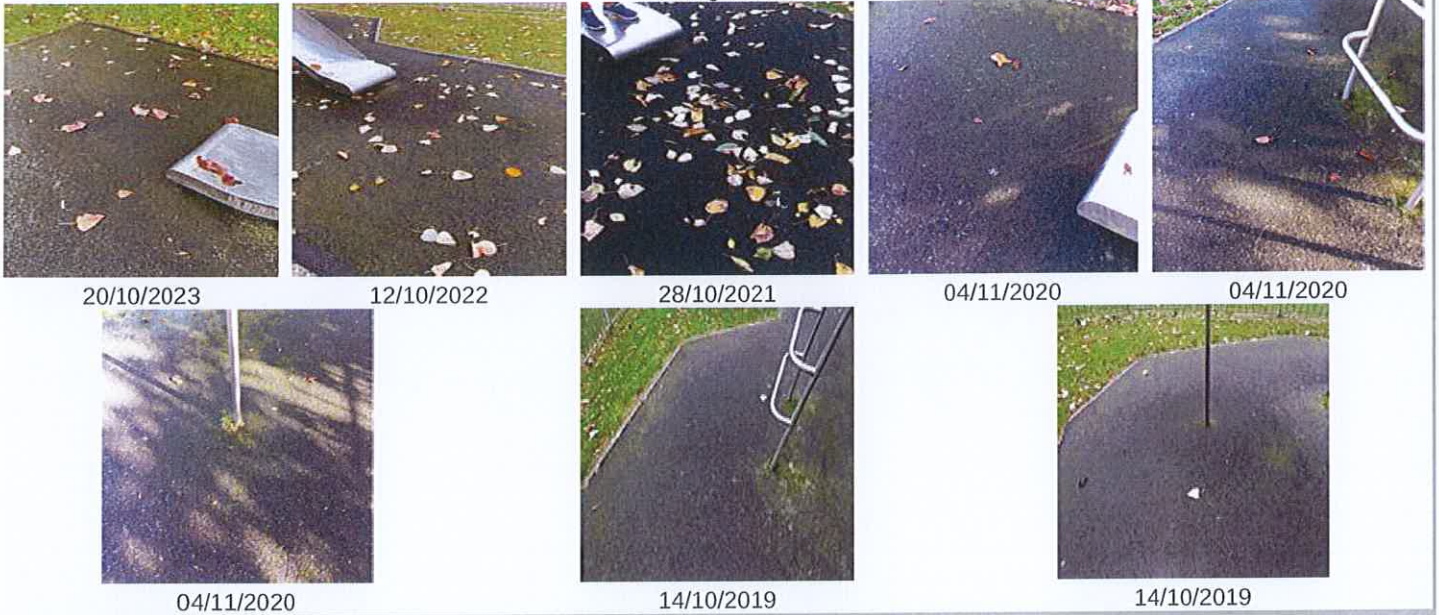
Surface - Wearing - Task

Task Title	Monitor
Task Notes	
Task Status	Unapproved

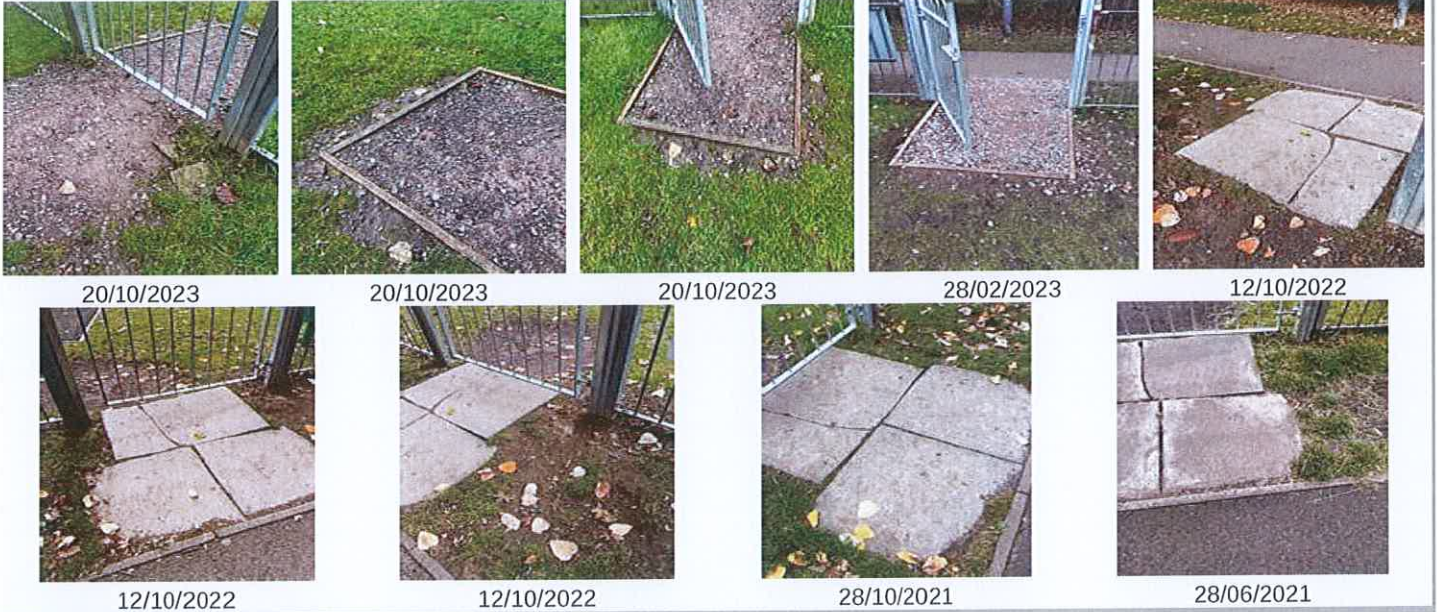
Surface - Trip points - Tasks

Task Title	Repair surface
Task Notes	
Task Status	Unapproved

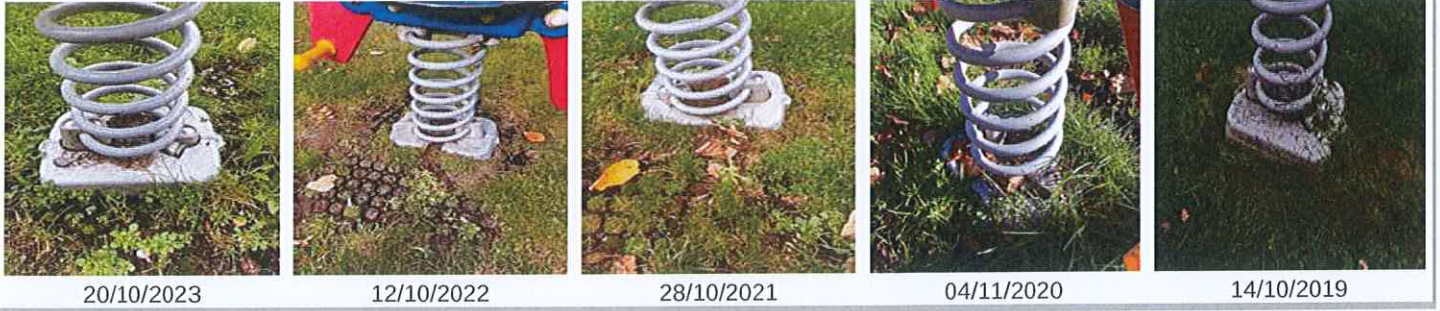
Item - Loose in Ground - Task

Task Title	Monitor
Task Notes	
Task Status	Unapproved

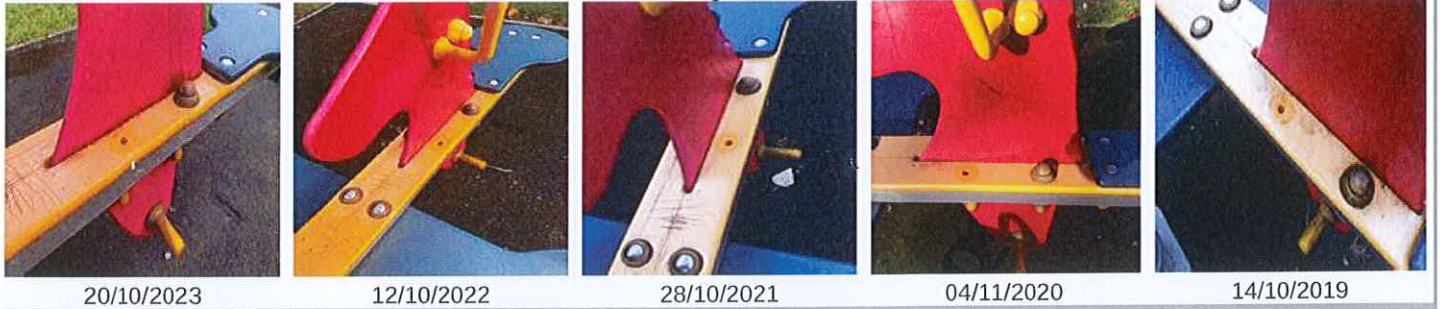
Fixtures - Loose or Missing - Task

Task Title	Replace missing fasteners, fixtures and fitting
Task Notes	
Task Status	Unapproved

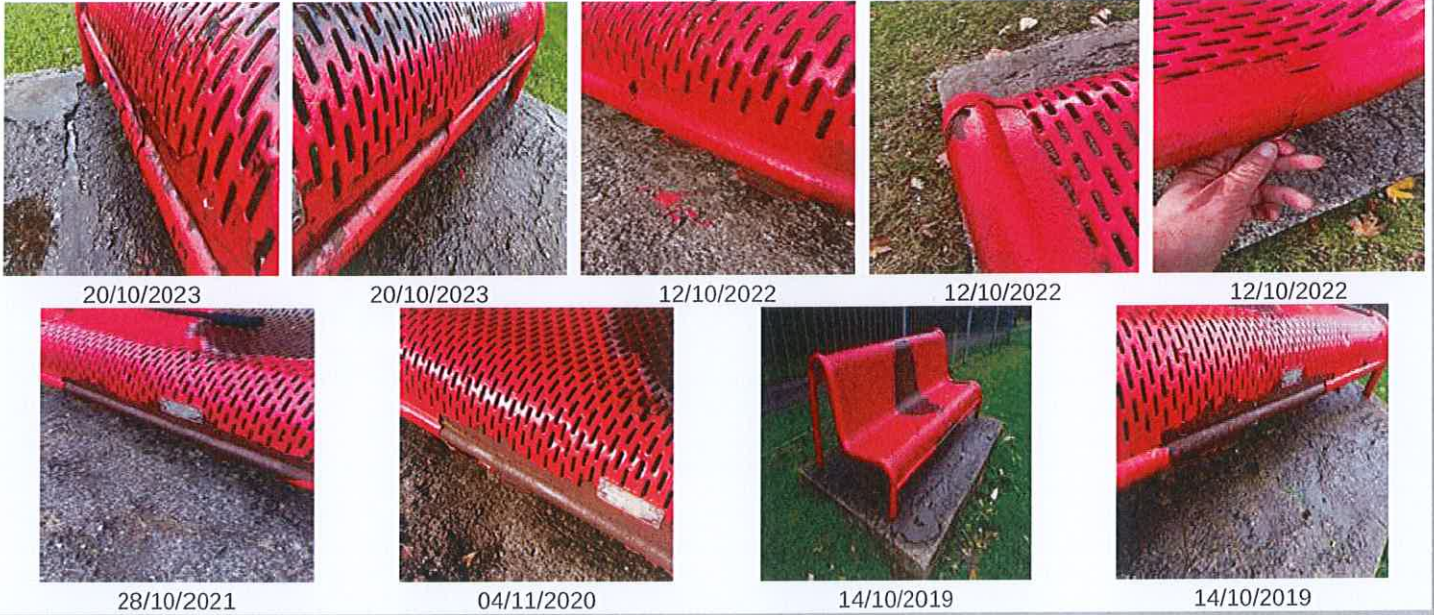
Item - Hard or Sharp Projections - Task

Task Title	Remove hard, pointed & sharp projections
Task Notes	
Task Status	Unapproved

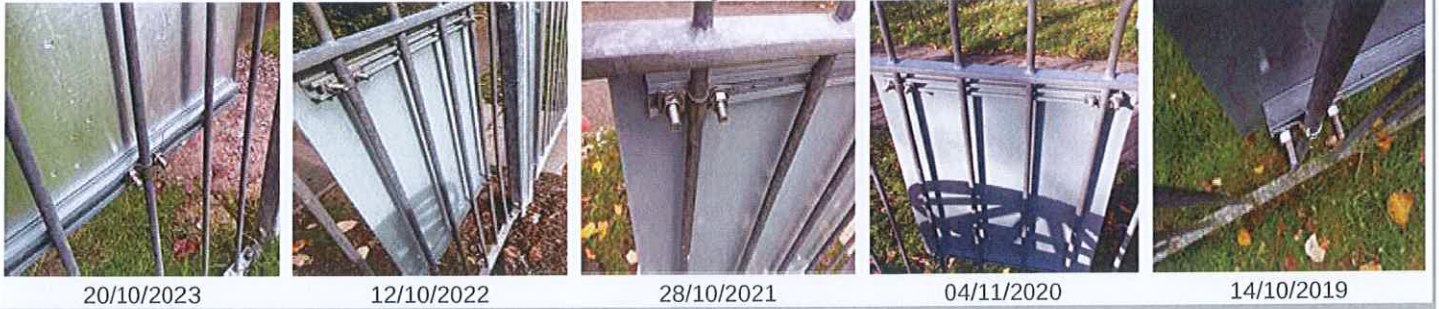
Finish - Bolts Protruding - Task

Task Title	Modify to meet EN 1176
Task Notes	Trim off excess length
Task Status	Unapproved

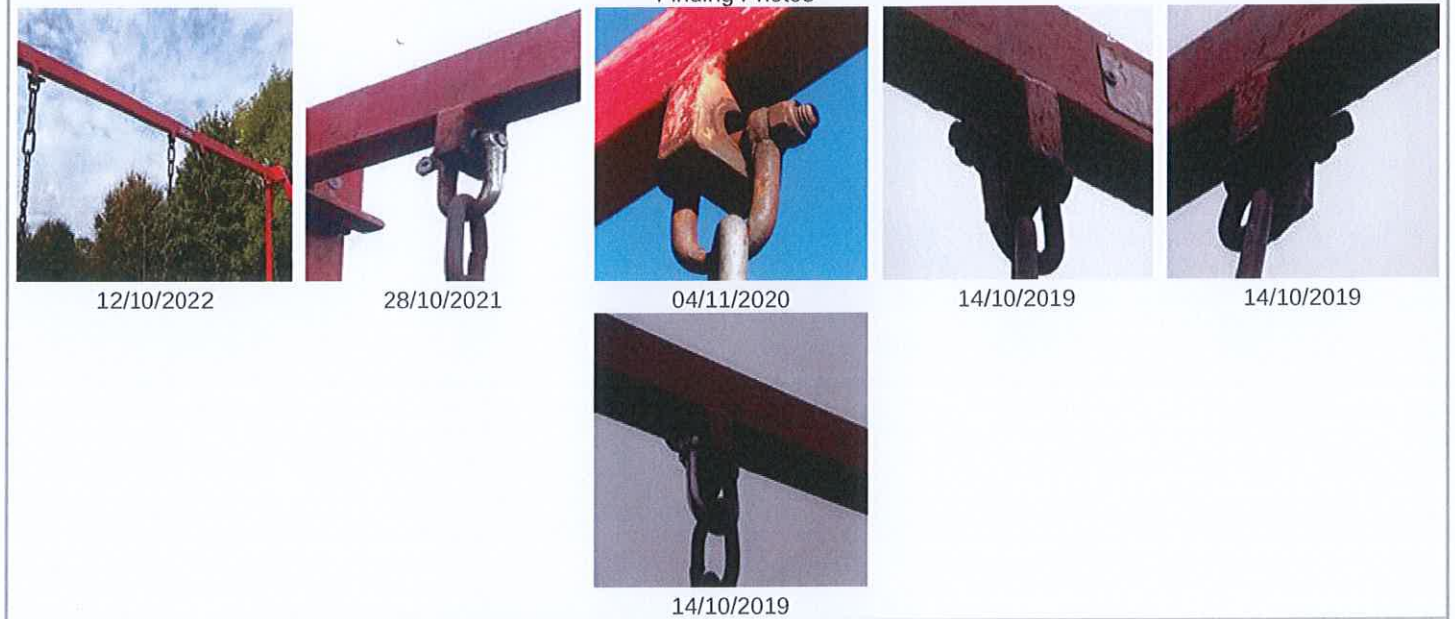
Swing - Shackles Bushes - Servicing - Task

Task Title	Service shackles and bushes
Task Notes	
Task Status	Completed

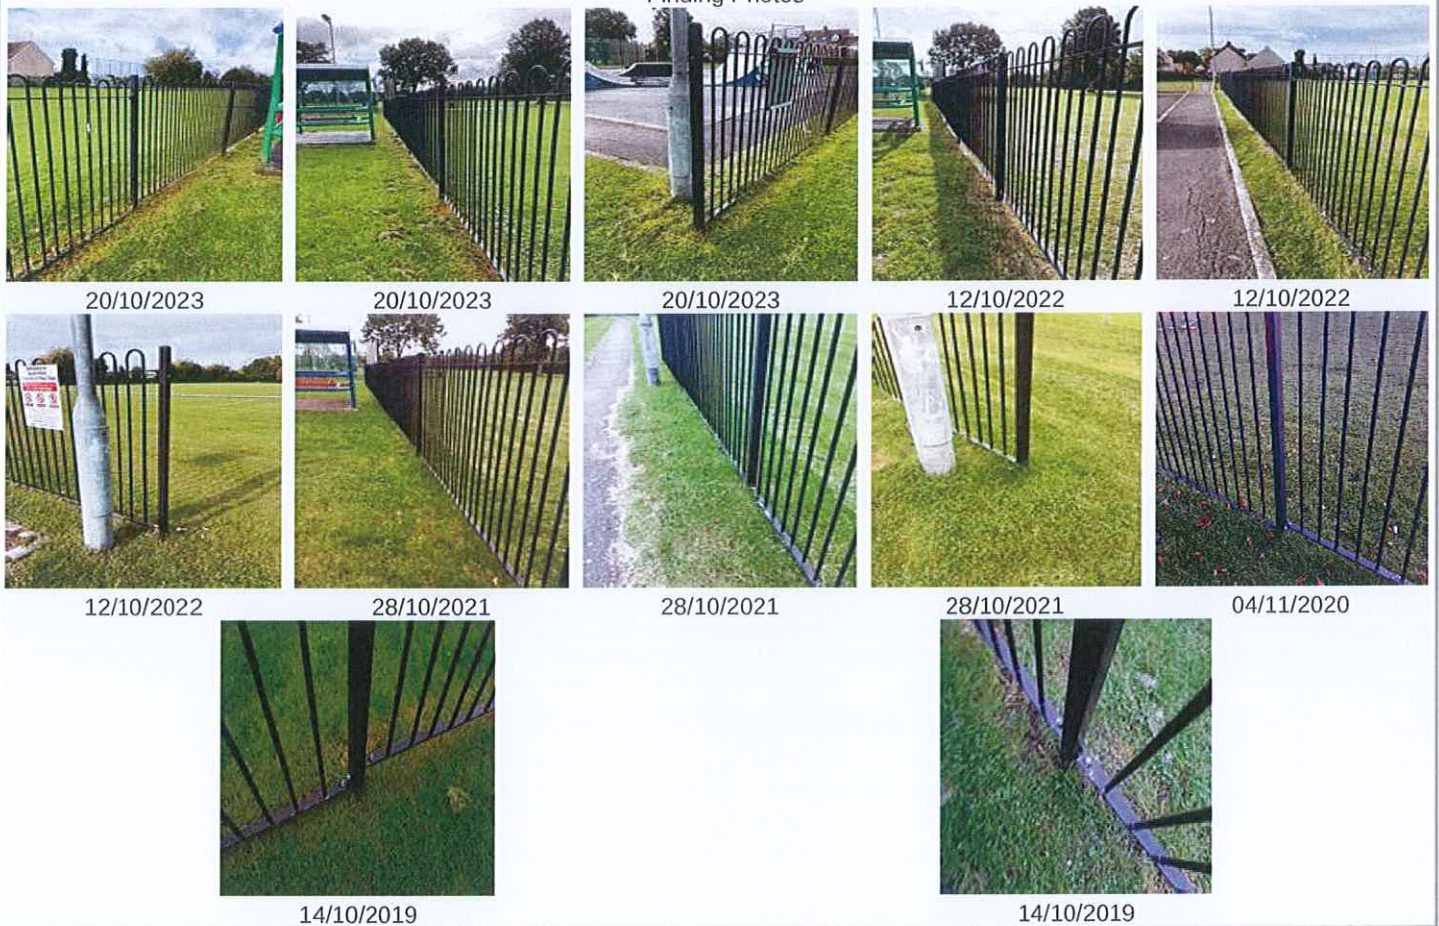
Item - Loose in Ground - Tasks

Task Title	Repair item
Task Notes	
Task Status	Unapproved

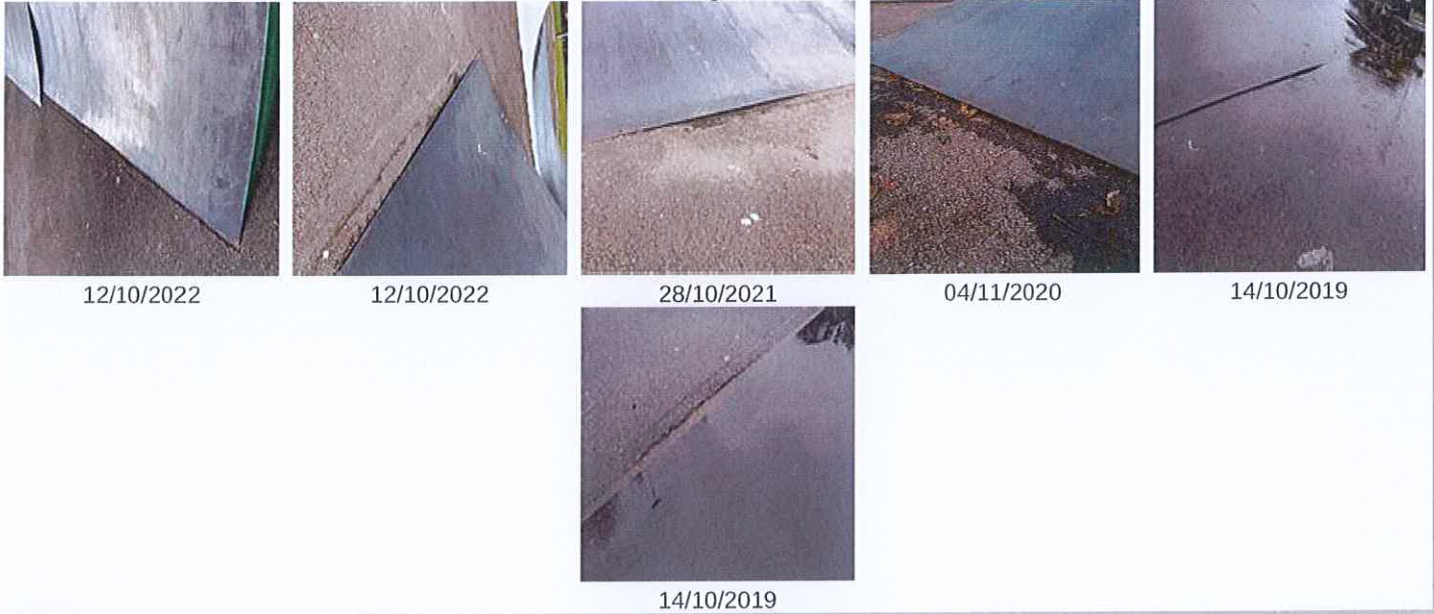
Safety Zone - Level Gaps - Task

Task Title	Refix the gap to be less than 5mm
Task Notes	
Task Status	Unapproved

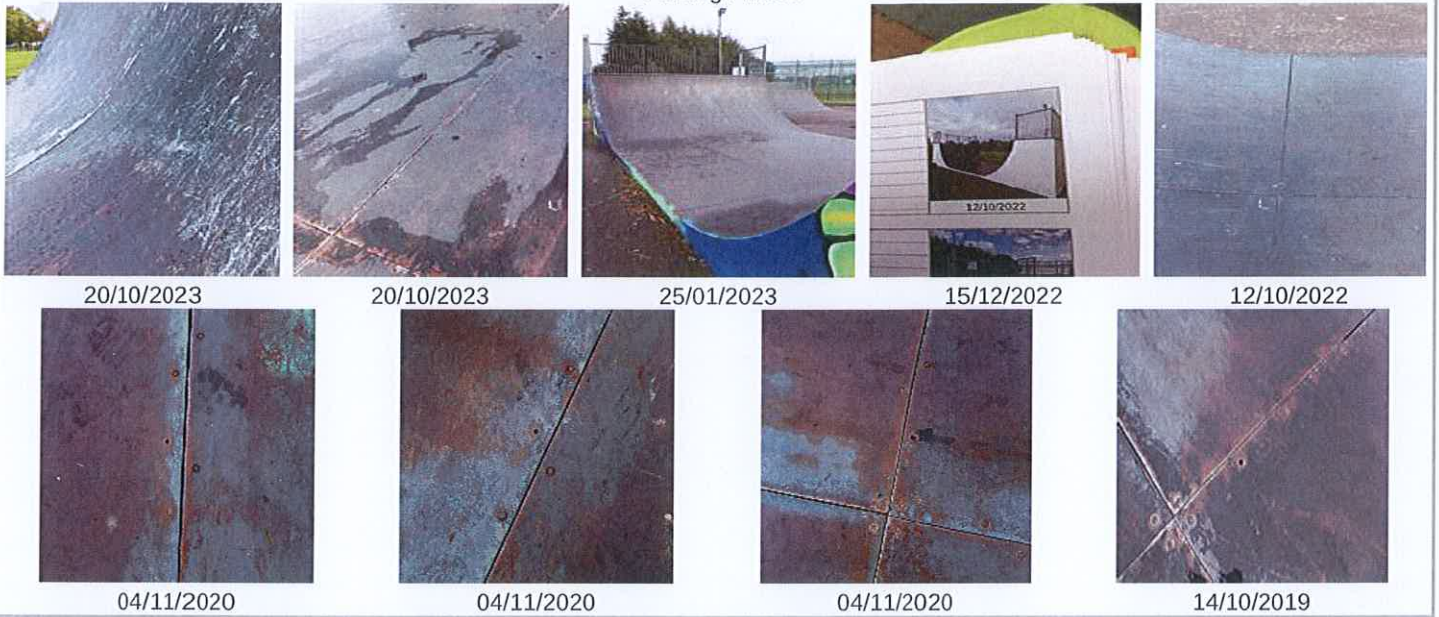
Fixtures - Loose or Missing - Task

Task Title	Replace missing fasteners, fixtures and fitting
Task Notes	
Task Status	Unapproved

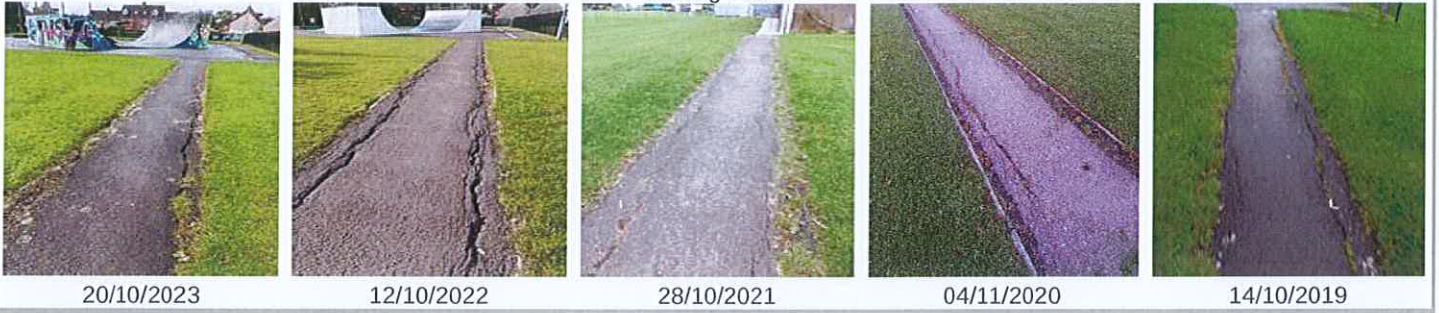
Surface - Trip points - Task

Task Title	Repair surface
Task Notes	
Task Status	Unapproved

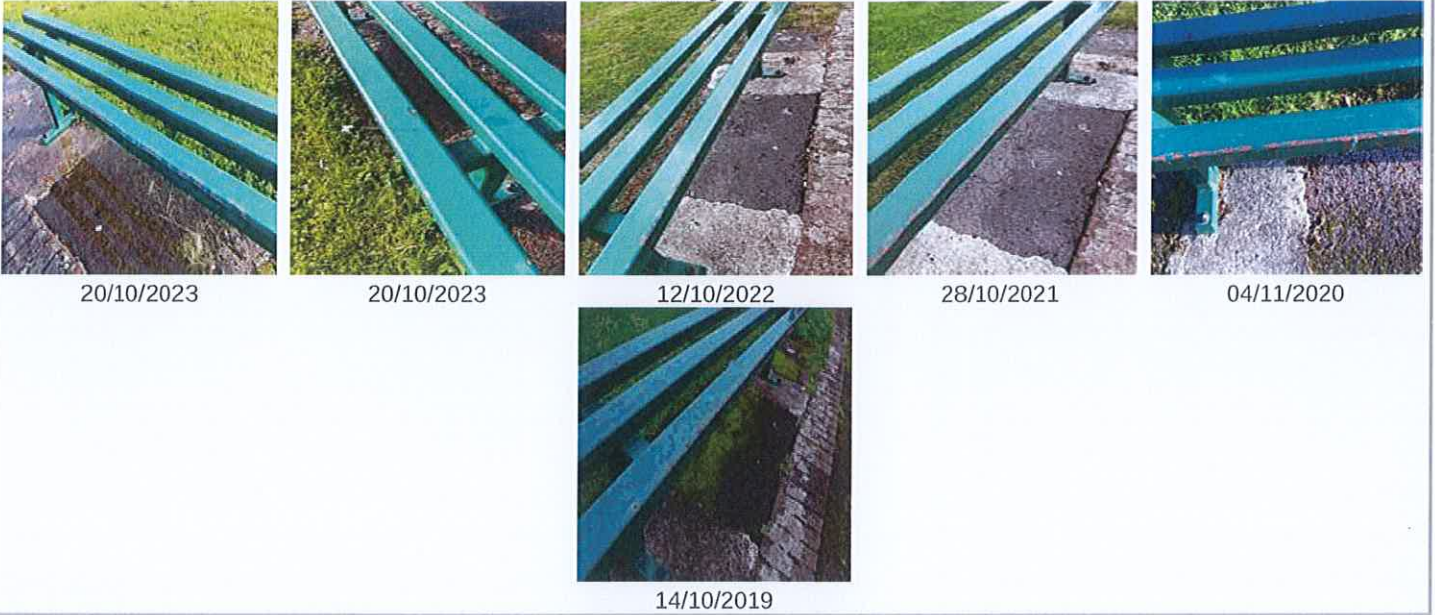
Item - Rusting in places - Task

Task Title	De-rust and coat with paint meeting EN 1176 - 4.1.1 [1998]
Task Notes	
Task Status	Unapproved

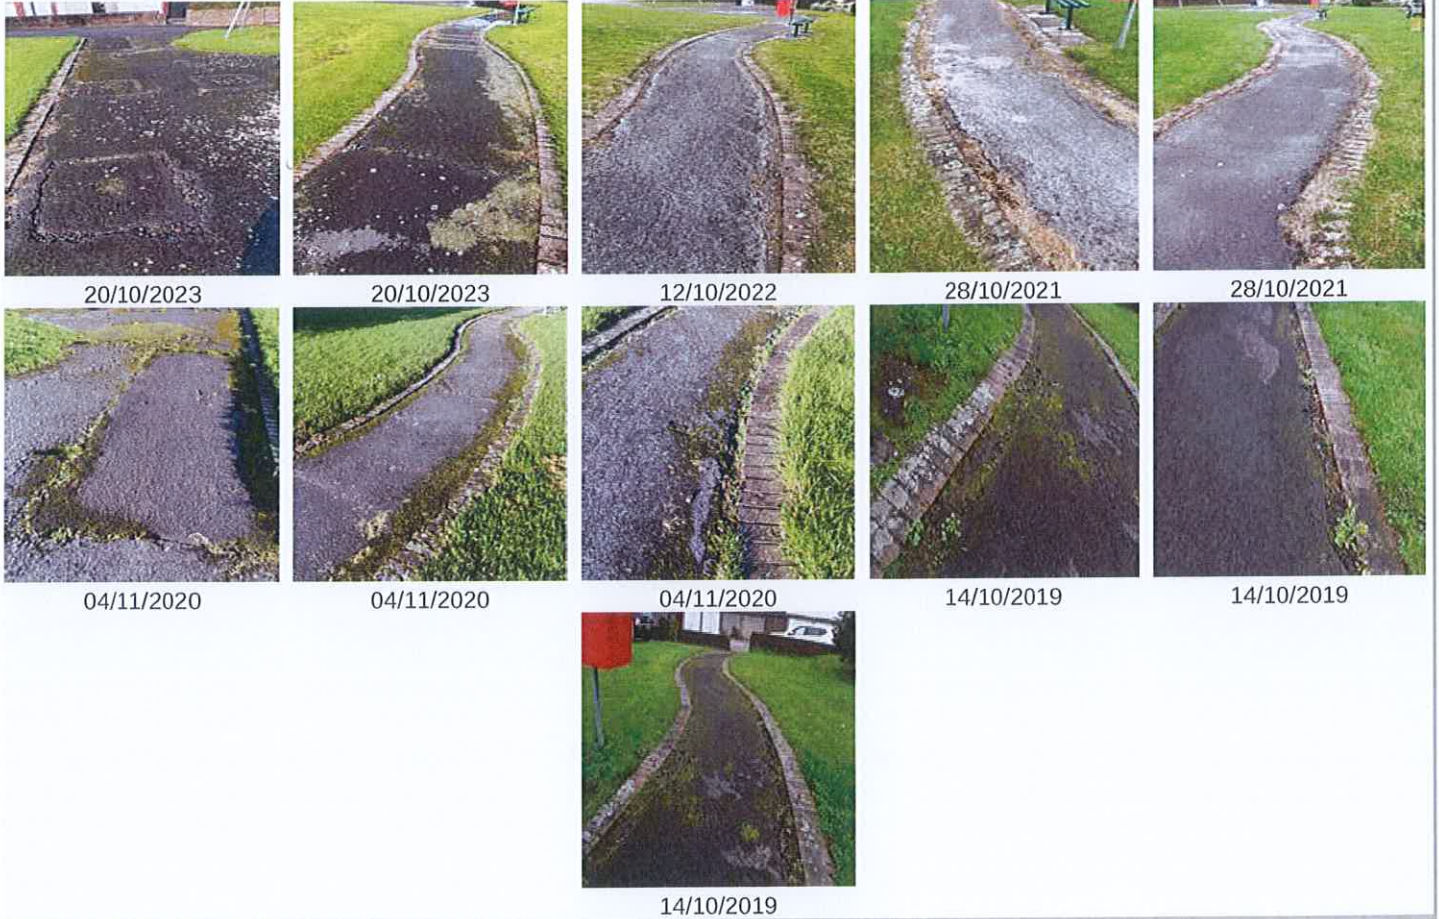
Surface - Trip points - Task

Task Title	Repair surface
Task Notes	
Task Status	Unapproved

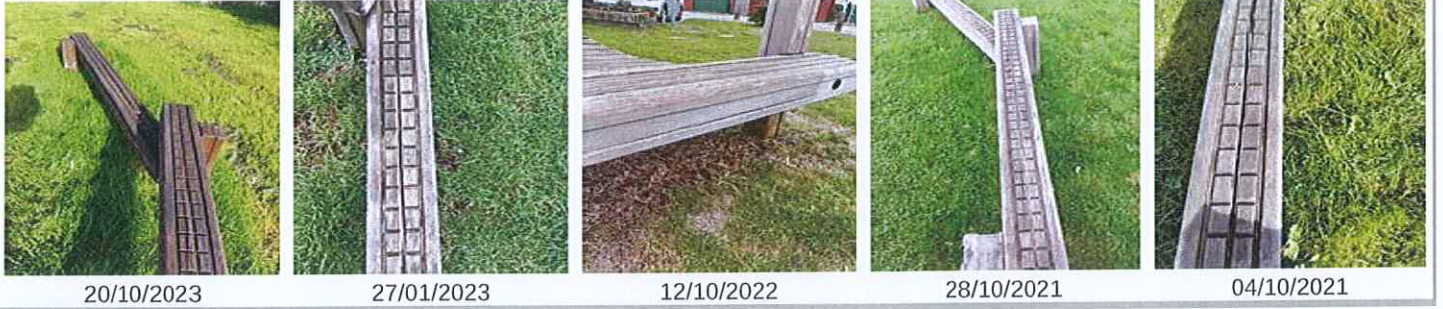
Timber - New Wide Cracks - Task

Task Title	Monitor
Task Notes	
Task Status	Unapproved

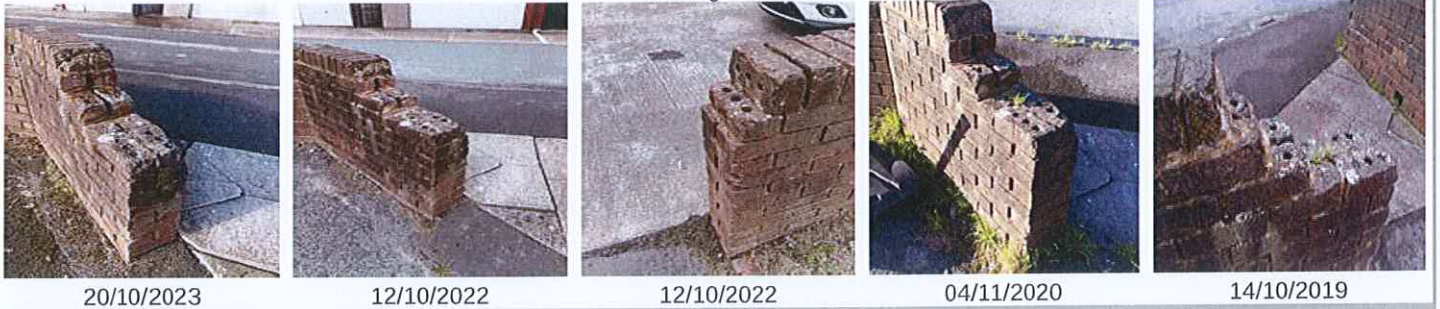
Item - Damaged - Task

Task Title	Repair item
Task Notes	
Task Status	Unapproved

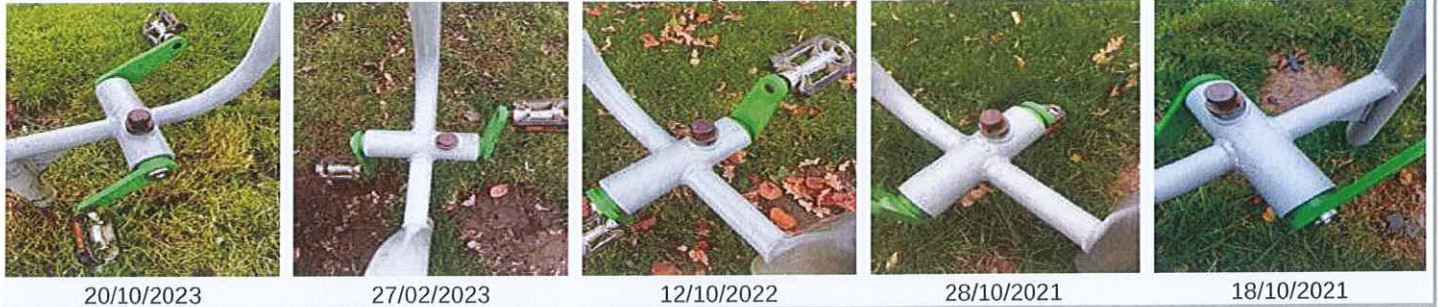
Item - Repair/s - Minor - Task

Task Title	Repair item
Task Notes	Advice to be obtained from manufacturer.
Task Status	Unapproved
