# Gordon Playground Inspections up **PSSLive**<sup>+</sup>

Annual Inspection 2024 Scott Park - Field and Gym Patchway Parish Council

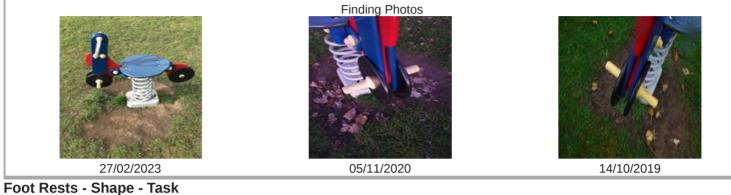
Asset	Field - Rocker Motorbike	C. C
Finding Group	BS EN 1176:2017 Part 6 (Rockers - Playground)	and the second second
Finding Title	Foot Rests - Shape	all such a second
Standard Reference	EN 1176:2017 - 6 - 4.6	
Standard Description	When tested in accordance with EN 1176 the ends of the foot rests do not comply with the requirements.	
Finding Notes	Now has brand new foot rests	and the second s
Cause	Manufacturer Defect	and the second second
Finding Creation Date	14/10/2019 13:30:00	
Risk Value Text	1 x 4 = 4	Asset Photo
Risk Level	Low	
Resolve By Date	24/09/2024 10:19:09	
Finding Status	Closed

Task Title	No action required, based on risk assessment, as asset pre-dates BSEN1176
Task Notes	Now has brand new foot rests
Task Status	Completed
