5. To consider reinstating the Patchway Greenway Walk.
6. To consider restoring the Living Landmark trail and signage in Patchway.
7. To elect members to a 'Pollinator Project' working group (3 members of the committee).
8. To note the Annual Play Area inspection report for 2023.

Minutes of the Meeting of the Parks, Open Spaces, Planning and Transport committee held on the Tuesday 3rd October 2023 at 20:00 at Callicroft House, Patchway.

**Gordon Playground
Inspections LTD PSSLive+**

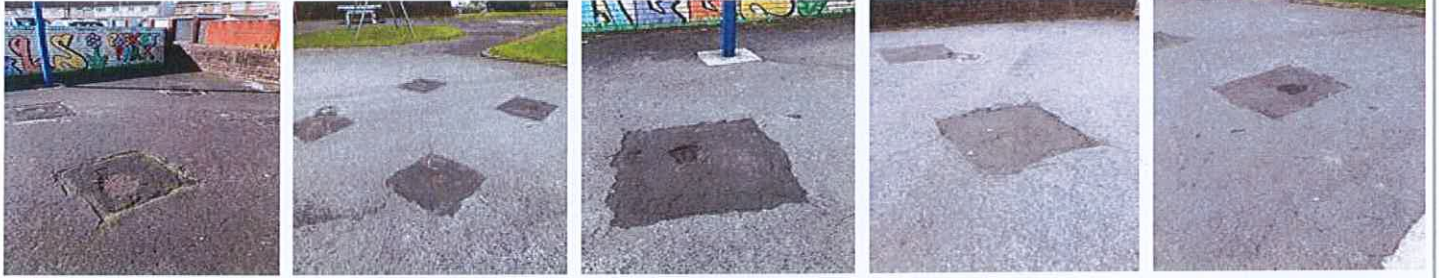
Asset	Basketball Post Surface
Finding Group	Maintenance
Finding Title	Surface - Uneven
Standard Reference	
Standard Description	Surface is uneven
Finding Notes	12.10.22 Condition deteriorated
Cause	Wear and Tear
Finding Creation Date	28/10/2021 14:12:59
Risk Value Text	2 x 3 = 6
Risk Level	Low
Resolve By Date	12/01/2024 11:56:01
Finding Status	Open
